# Access Compliance Report

## Public Rights-of-Way

### (Curb Ramps)

Intersection ID: 42741	Main Street: DANIEL_PLACE_DR	Cross Street: MACANTHRA_DR	Location: NW
ADA ID: 2730EA87A0D6	Ramp Type: PerpDiag	Initial Pass/Fail: Fail	Overall Compliance: No
Severity Score: 46.25			
Codes/Mitigation Info/Possible Solution		Field Measurements/Component Compliance

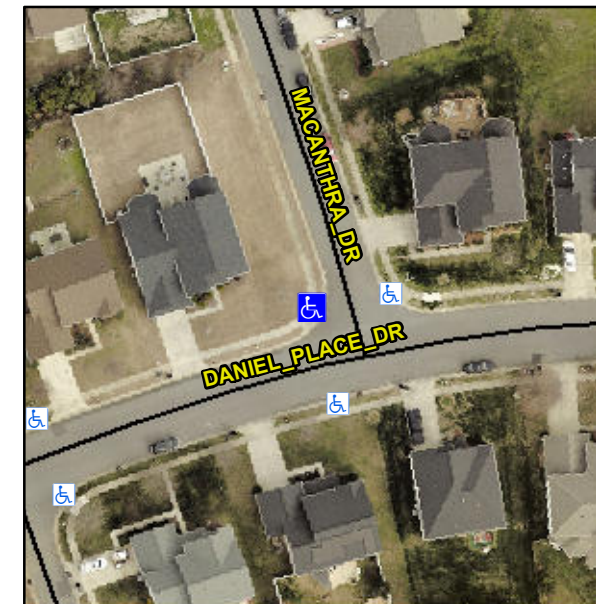
**Not Found, R304.5.1, R304.2.2, R304.5.3**

Compliance	Description	Data	Compliance	Description	Data
N/A	Ramp Length (in)	50.5	No	Ramp Slope (%)	9.7
No	Ramp Width (in)	41.0	No	Ramp XSlope (%)	9.3
N/A	Flare Type LT	N/A	N/A	Flare Type RT	N/A
N/A	Flare Slope LT (%)	N/A	N/A	Flare Slope RT (%)	N/A
N/A	Flare Traversable LT?	N/A	N/A	Flare Traversable RT?	N/A
N/A	Landing Length (in)	N/A	N/A	DWS Provided?	N/A
N/A	Landing Width (in)	N/A	N/A	DWS Contrast?	N/A
N/A	Landing Slope (%)	N/A	N/A	DWS Length (in)	N/A
N/A	Landing X Slope (%)	N/A	N/A	DWS Full Width?	N/A
N/A	Landing Curb? (Y/N)	N/A	N/A	DWS Offset (in)	N/A
N/A	Shared Landing?	N/A			
N/A	Gutter Ponding?	N/A	N/A	Gutter Slope (%)	N/A
N/A	Gutter Lip Ht (in)	N/A	N/A	Gutter X Slope (%)	N/A
N/A	Painted X Walk1?	No	N/A	Painted X Walk2?	No
	X Walk 1 Direction	To S		X Walk 2 Direction	To E
N/A	X Walk 1 Width (in)	N/A	N/A	X Walk 2 Width (in)	N/A
	X Walk 1 Slope (%)	3.0		X Walk 2 Slope (%)	8.6
	X Walk 1 X Slope (%)	6.4		X Walk 2 X Slope (%)	8.2

N/A	Ramp inside XWalk1?	N/A	N/A	Ramp inside XWalk2?	N/A
	Road Slope (%)	9.5	N/A	Clear Space?	N/A
	Road X Slope (%)	1.4	N/A	Clear Space to XWalk (in)	N/A
N/A	Any Obstructions?	N/A	N/A	Storm Grate/Utility Hazard?	N/A
	Obstruction Type			Storm Grate/Utility Type	
		N/A			N/A
			Yes	Surface Condition? (G/P)	Good

**Remove & Replace Curb Ramp With Two New Directional Ramps or Equivalent.**
