Access Compliance Report

Public Rights-of-Way

(Curb Ramps)

Intersection ID: N/A	Main Street: SOUTH_BV	Cross Street: LONGLEAF_RD	Location: NW
ADA ID: 2731E33C6C4A	Ramp Type: Directional1	Initial Pass/Fail: Pass	Overall Compliance: No
		Severity Score: 0

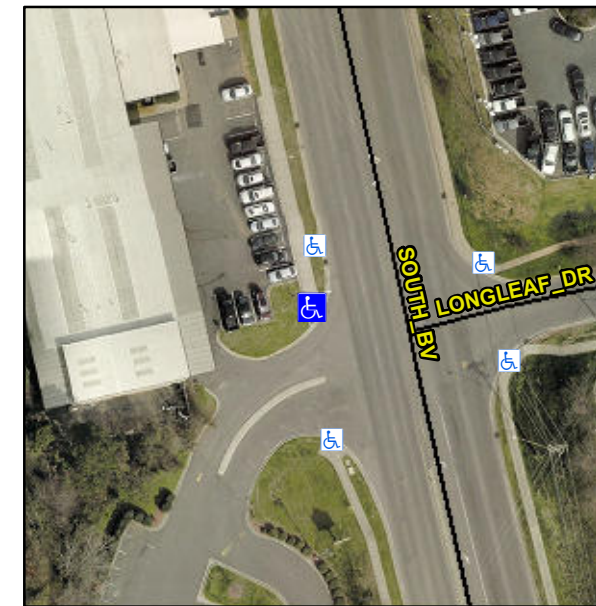
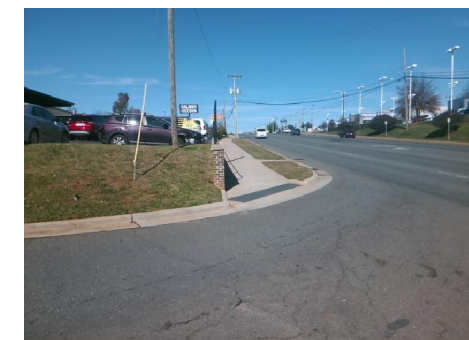
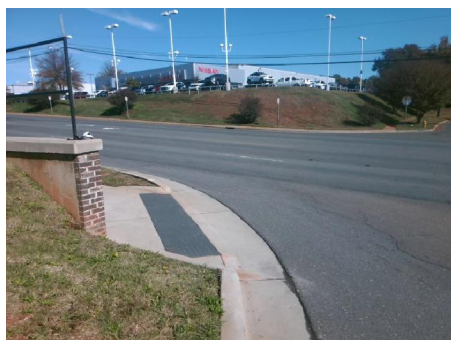
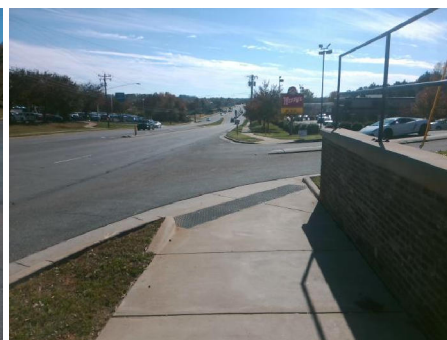
Compliance	Description	Data	Compliance	Description	Data
N/A	Ramp Length (in)	71.0	No	Grade Break?	No
Yes	Ramp Width (in)	95.0	N/A	Grade Break Slope (%)	N/A
Yes	Ramp Slope (%)	4.7	N/A	Grade Break XSlope (%)	N/A
Yes	Ramp XSlope (%)	0.6			
Yes	Flare Type LT	N/A	Yes	Flare Type RT	N/A
N/A	Flare Slope LT (%)	N/A	N/A	Flare Slope RT (%)	N/A
N/A	Flare Traversable LT?	No	N/A	Flare Traversable RT?	No
Yes	Landing Length (in)	51.0	Yes	DWS Provided?	Yes
Yes	Landing Width (in)	95.0	Yes	DWS Contrast?	Yes
No	Landing Slope (%)	4.3	Yes	DWS Length (in)	24.0
Yes	Landing X Slope (%)	2.5	Yes	DWS Full Width?	Yes
N/A	Landing Curb? (Y/N)	N/A	Yes	DWS Offset LT (in)	0.0
N/A	Shared Landing?	No	Yes	DWS Offset RT (in)	0.0
Yes	Gutter Ponding?	No	Yes	Gutter Slope (%)	1.6
Yes	Gutter Lip Ht (in)	0.0	Yes	Gutter X Slope (%)	2.3
N/A	Painted X Walk1?	No		Road Slope (%)	11.6
	X Walk 1 Direction	To S		Road X Slope (%)	5.6
	X Walk 1 Width (in)	N/A		Clear Space?	Yes

X Walk 1 Slope (%)	11.6	N/A	Clear Space to XWalk (in)	N/A
	X Walk 1 X Slope (%)	5.6	Yes	Storm Grate/Utility Hazard?	No
N/A	Ramp inside XWalk1?	N/A		Storm Grate/Utility Type	
Yes	Any Obstructions?	No			N/A
	Obstruction Type		Yes	Surface Condition? (G/P)	Good
			N/A	Curb Slope (%)	7.2

Remove & Replace Entire Ramp.

R304.2.2-Perp, R304.3.2-Para, R304.5.2
