Access Compliance Report

Public Rights-of-Way

(Curb Ramps)

Intersection ID: 14515	Main Street: QUEENS_RD	Cross Street: S_CASWELL_RD	Location: NE
ADA ID: 2737EA7DBFCD	Ramp Type: PerpDiag	Initial Pass/Fail: Fail	Overall Compliance: No
Severity Score: 12.5			
Codes/Mitigation Info/Possible Solution		Field Measurements/Component Compliance

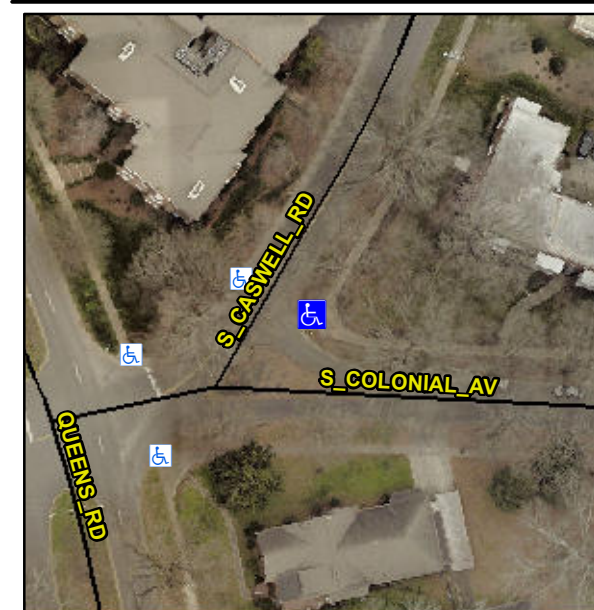
Compliance	Description	Data	Compliance	Description	Data
N/A	Ramp Length (in)	78.0	Yes	Ramp Slope (%)	7.3
Yes	Ramp Width (in)	48.0	No	Ramp XSlope (%)	6.7
N/A	Flare Type LT	N/A	N/A	Flare Type RT	N/A
N/A	Flare Slope LT (%)	N/A	N/A	Flare Slope RT (%)	N/A
N/A	Flare Traversable LT?	N/A	N/A	Flare Traversable RT?	N/A
N/A	Landing Length (in)	N/A	N/A	DWS Provided?	N/A
N/A	Landing Width (in)	N/A	N/A	DWS Contrast?	N/A
N/A	Landing Slope (%)	N/A	N/A	DWS Length (in)	N/A
N/A	Landing X Slope (%)	N/A	N/A	DWS Full Width?	N/A
N/A	Landing Curb? (Y/N)	N/A	N/A	DWS Offset (in)	N/A
N/A	Shared Landing?	N/A			
N/A	Gutter Ponding?	N/A	N/A	Gutter Slope (%)	N/A
N/A	Gutter Lip Ht (in)	N/A	N/A	Gutter X Slope (%)	N/A
N/A	Painted X Walk1?	No	N/A	Painted X Walk2?	No
	X Walk 1 Direction	To NW		X Walk 2 Direction	To SW
N/A	X Walk 1 Width (in)	N/A	N/A	X Walk 2 Width (in)	N/A
	X Walk 1 Slope (%)	0.4		X Walk 2 Slope (%)	0.2
	X Walk 1 X Slope (%)	1.2		X Walk 2 X Slope (%)	1.3

N/A	Ramp inside XWalk1?	N/A	N/A	Ramp inside XWalk2?	N/A
	Road Slope (%)	2.2	N/A	Clear Space?	N/A
	Road X Slope (%)	5.5	N/A	Clear Space to XWalk (in)	N/A
N/A	Any Obstructions?	N/A	N/A	Storm Grate/Utility Hazard?	N/A
	Obstruction Type			Storm Grate/Utility Type	
		N/A			N/A
		Yes		Surface Condition? (G/P)	Good

Remove & Replace Curb Ramp With Two New Directional Ramps or Equivalent.
