Access Compliance Report

Public Rights-of-Way

(Curb Ramps)

Intersection ID: 3163	Main Street: BASKERVILLE_AV	Cross Street: PROSPERITY_CHURCH_RD	Location: SE
ADA ID: 273A92C28530	Ramp Type: Perp	Initial Pass/Fail: Fail	Overall Compliance: No
			Severity Score: 21.25

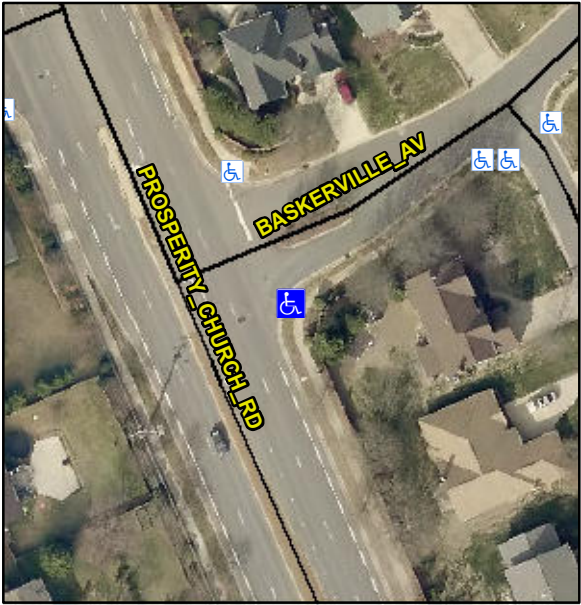
Possible Solutions:		Compliance	Description	Data
	Remove & Replace Entire Ramp.		No	Ramp Length (in)	73.0
			No	Ramp Width (in)	40.5
			N/A	Flare Type LT	N/A
			N/A	Flare Slope LT (%)	N/A
			N/A	Flare Traversable LT?	N/A
			N/A	Landing Length (in)	N/A
			N/A	Landing Width (in)	N/A
			N/A	Landing Slope (%)	N/A
			N/A	Landing X Slope (%)	N/A
<p>Surveyor Notes:</p> <p>N/A</p>			N/A	Landing Curb? (Y/N)	N/A
			N/A	Shared Landing?	N/A
			N/A	Gutter Ponding?	N/A
			N/A	Gutter Lip Ht (in)	N/A
			N/A	Painted X Walk1?	No
				X Walk 1 Direction	To N
			N/A	X Walk 1 Width (in)	N/A
				X Walk 1 Slope (%)	1.0
				X Walk 1 X Slope (%)	2.1
			N/A	Ramp inside XWalk1?	N/A
<p>PROW/ADA:</p> <p>Not Found, R304.5.1, R304.2.2</p>			N/A	Road Slope (%)	N/A
			N/A	Road X Slope (%)	N/A
			N/A	Any Obstructions?	N/A
				Obstruction Type	
			N/A		
			N/A		
			N/A
