# Access Compliance Report

## Public Rights-of-Way

### (Curb Ramps)

Intersection ID: 11878	Main Street: MIMOSA_AV	Cross Street: THE_PLAZA	Location: SW
ADA ID: 274139646300	Ramp Type: Perp	Initial Pass/Fail: Fail	Overall Compliance: No
			Severity Score: 13.75

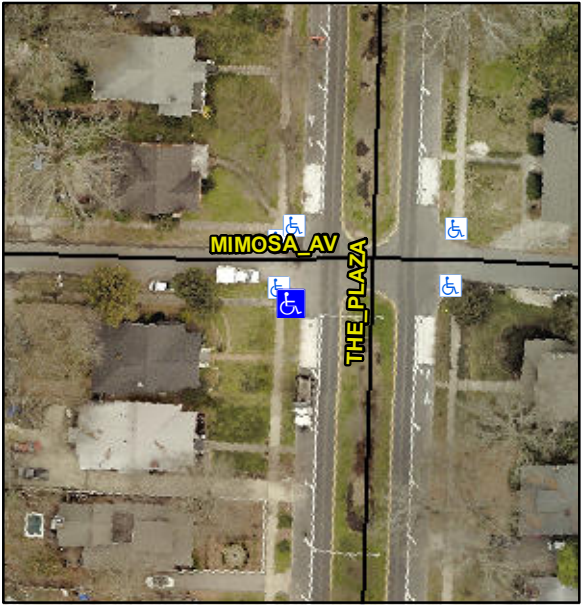
Possible Solutions:		<b>Compliance</b>	<b>Description</b>	<b>Data</b>
	Remove & Replace Entire Ramp.		N/A	Ramp Length (in)	66.0
			Yes	Ramp Width (in)	68.0
			N/A	Flare Type LT	N/A
			N/A	Flare Slope LT (%)	N/A
			N/A	Flare Traversable LT?	N/A
			N/A	Landing Length (in)	N/A
			N/A	Landing Width (in)	N/A
			N/A	Landing Slope (%)	N/A
			N/A	Landing X Slope (%)	N/A
<p>Surveyor Notes:</p> <p>N/A</p> <p>PROW/ADA:</p> <p>R304.2.2, R304.5.3</p>			N/A	Flare Type RT	N/A
			N/A	Flare Slope RT (%)	N/A
			N/A	Flare Traversable RT?	N/A
			N/A	DWS Provided?	N/A
			N/A	DWS Contrast?	N/A
			N/A	DWS Length (in)	N/A
			N/A	DWS Full Width?	N/A
			N/A	DWS Offset (in)	N/A
			N/A	Shared Landing?	N/A
			N/A	Gutter Ponding?	Yes
<p>Street 1 Name</p> <p>Stop Condition-Street 2</p> <p>Street 2 Name</p> <p>Stop Condition-Street 1</p>			N/A	Gutter Lip Ht (in)	N/A
