Access Compliance Report

Public Rights-of-Way

(Curb Ramps)

Intersection ID: 42768	Main Street: DANIEL_PLACE_DR	Cross Street: GODSEY_WOOD_DR	Location: SW
ADA ID: 27468A598A7A	Ramp Type: PerpDiag	Initial Pass/Fail: Fail	Overall Compliance: No
Codes/Mitigation Info/Possible Solution		Field Measurements/Component Compliance

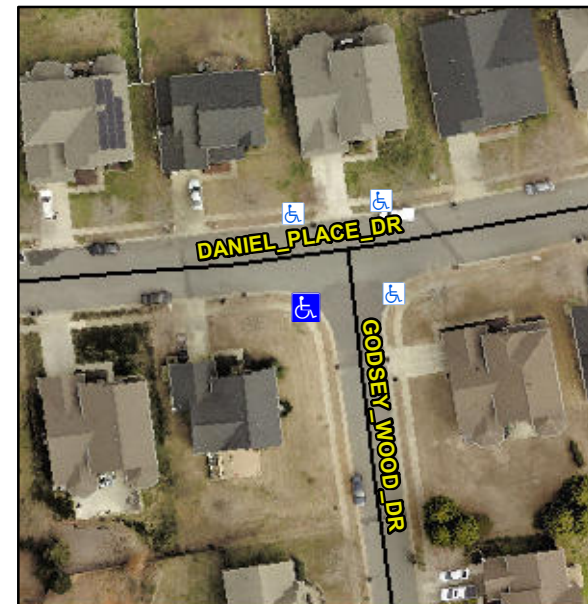
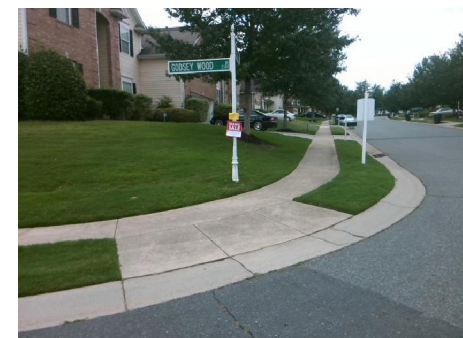
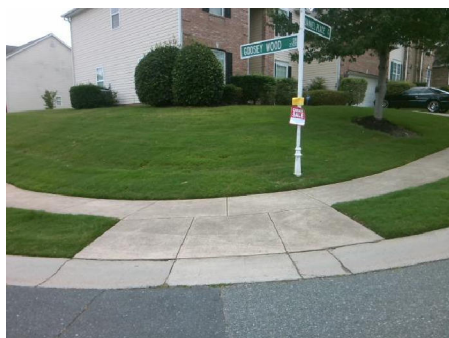
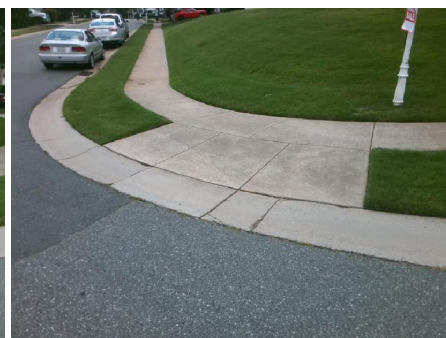
Not Found, R304.5.1, R304.2.2, R304.5.3

Compliance	Description	Data	Compliance	Description	Data
N/A	Ramp Length (in)	47.0	No	Ramp Slope (%)	11.7
No	Ramp Width (in)	43.0	No	Ramp XSlope (%)	6.1
N/A	Flare Type LT	N/A	N/A	Flare Type RT	N/A
N/A	Flare Slope LT (%)	N/A	N/A	Flare Slope RT (%)	N/A
N/A	Flare Traversable LT?	N/A	N/A	Flare Traversable RT?	N/A
N/A	Landing Length (in)	N/A	N/A	DWS Provided?	N/A
N/A	Landing Width (in)	N/A	N/A	DWS Contrast?	N/A
N/A	Landing Slope (%)	N/A	N/A	DWS Length (in)	N/A
N/A	Landing X Slope (%)	N/A	N/A	DWS Full Width?	N/A
N/A	Landing Curb? (Y/N)	N/A	N/A	DWS Offset (in)	N/A
N/A	Shared Landing?	N/A			
N/A	Gutter Ponding?	N/A	N/A	Gutter Slope (%)	N/A
N/A	Gutter Lip Ht (in)	N/A	N/A	Gutter X Slope (%)	N/A
N/A	Painted X Walk1?	No	N/A	Painted X Walk2?	No
	X Walk 1 Direction	To E		X Walk 2 Direction	To N
N/A	X Walk 1 Width (in)	N/A	N/A	X Walk 2 Width (in)	N/A
	X Walk 1 Slope (%)	4.8		X Walk 2 Slope (%)	4.6
	X Walk 1 X Slope (%)	2.3		X Walk 2 X Slope (%)	2.1

N/A	Ramp inside XWalk1?	N/A	N/A	Ramp inside XWalk2?	N/A
	Road Slope (%)	3.4	N/A	Clear Space?	N/A
	Road X Slope (%)	1.7	N/A	Clear Space to XWalk (in)	N/A
N/A	Any Obstructions?	N/A	N/A	Storm Grate/Utility Hazard?	N/A
	Obstruction Type			Storm Grate/Utility Type	
		N/A			N/A
			Yes	Surface Condition? (G/P)	Good

Remove & Replace Curb Ramp With Two New Directional Ramps or Equivalent.
