# Access Compliance Report

## Public Rights-of-Way

### (Curb Ramps)

Intersection ID: 30152	Main Street: HARLAND_ST	Cross Street: KARNAK_CT	Location: W
ADA ID: 274CCD6E3838	Ramp Type: BlendTrans1	Initial Pass/Fail: Fail	Overall Compliance: No
		Severity Score: 12.5

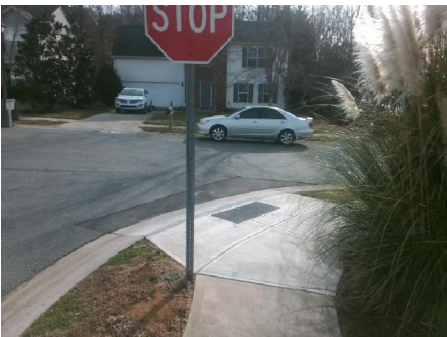
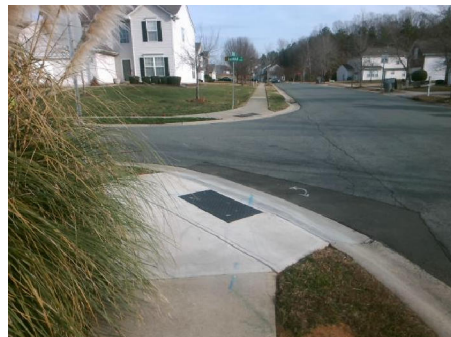
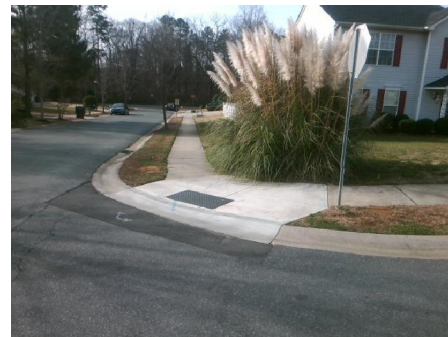
**Not Found, R304.5.3**

Compliance	Description	Data	Compliance	Description	Data
N/A	Ramp Length (in)	42.5	Yes	BlendTrans Slope (%)	4.1
Yes	Ramp Width (in)	48.0	No	BlendTrans XSlope (%)	5.1
N/A	Flare Type LT	N/A	N/A	Flare Type RT	N/A
N/A	Flare Slope LT (%)	N/A	N/A	Flare Slope RT (%)	N/A
N/A	Flare Traversable LT?	N/A	N/A	Flare Traversable RT?	N/A
N/A	Landing Length (in)	N/A	N/A	DWS Provided?	N/A
N/A	Landing Width (in)	N/A	N/A	DWS Contrast?	N/A
N/A	Landing Slope (%)	N/A	N/A	DWS Length (in)	N/A
N/A	Landing X Slope (%)	N/A	N/A	DWS Full Width?	N/A
N/A	Landing Curb? (Y/N)	N/A	N/A	DWS Offset (in)	N/A
N/A	Shared Landing?	N/A			
N/A	Gutter Ponding?	N/A	N/A	Gutter Slope (%)	N/A
N/A	Gutter Lip Ht (in)	N/A	N/A	Gutter X Slope (%)	N/A
N/A	Painted X Walk1?	No	N/A	Painted X Walk2?	No
	X Walk 1 Direction	To SE		X Walk 2 Direction	To NE
	X Walk 1 Width (in)	N/A		X Walk 2 Width (in)	N/A
	X Walk 1 Slope (%)	1.2		X Walk 2 Slope (%)	3.3
	X Walk 1 X Slope (%)	4.0		X Walk 2 X Slope (%)	1.1

N/A	Ramp inside XWalk1?	N/A	N/A	Ramp inside XWalk2?	N/A
	Road Slope (%)	1.9		Clear Space?	N/A
	Road X Slope (%)	2.8	N/A	Clear Space to XWalk (in)	N/A
N/A	Any Obstructions?	N/A	N/A	Storm Grate/Utility Hazard?	N/A
	Obstruction Type			Storm Grate/Utility Type	
		N/A			N/A
			Yes	Surface Condition? (G/P)	Good
			No	Curb Slope (%)	9.8

**Remove & Replace Curb Ramp With Two New Directional Ramps or Equivalent.**
