Access Compliance Report Public Rights-of-Way (Curb Ramps)

Intersection ID: 10030508 Main Street: LITTLE_GEM_LN Cross Street: N/A Location: E

ADA ID: 2750D07C370A Ramp Type: Perp Initial Pass/Fail: Fail Overall Compliance: No Severity Score: 12.5

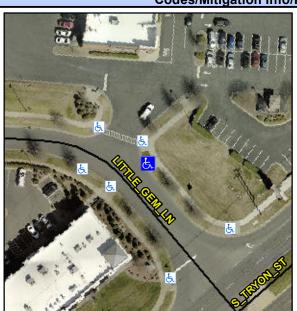
Not Found, R304.5.3

Field Measurements/Component Compliance								
Comp	liance Description	Data	Comp	liance Description	Data			
N/A	Ramp Length (in)	128.0	Yes	Ramp Slope (%)	5.4			
Yes	Ramp Width (in)	63.0	No	Ramp XSlope (%)	5.5			
N/A	Flare Type LT	N/A	N/A	Flare Type RT	N/A			
N/A	Flare Slope LT (%)	N/A	N/A	Flare Slope RT (%)	N/A			
N/A	Flare Traversable LT?	N/A	N/A	Flare Traversable RT?	N/A			
N/A	Landing Length (in)	N/A	N/A	DWS Provided?	N/A			
N/A	Landing Width (in)	N/A	N/A	DWS Contrast?	N/A			
N/A	Landing Slope (%)	N/A	N/A	DWS Length (in)	N/A			
N/A	Landing X Slope (%)	N/A	N/A	DWS Full Width?	N/A			
N/A	Landing Curb? (Y/N)	N/A	N/A	DWS Offset (in)	N/A			
N/A	Shared Landing?	N/A						
N/A	Gutter Ponding?	N/A	N/A	Gutter Slope (%)	N/A			
N/A	Gutter Lip Ht (in)	N/A	N/A	Gutter X Slope (%)	N/A			
N/A	Painted X Walk1?	No	N/A	Painted X Walk2?	N/A			
	X Walk 1 Direction	To SW		X Walk 2 Direction	N/A			
N/A	X Walk 1 Width (in)	N/A	N/A	X Walk 2 Width (in)	N/A

X Walk 1 Slope (%)	2.8		X Walk 2 Slope (%)	N/A			
	X Walk 1 X Slope (%)	2.5		X Walk 2 X Slope (%)	N/A			
N/A	Ramp inside XWalk1?	N/A	N/A	Ramp inside XWalk2?	N/A			
	Road Slope (%)	N/A	N/A	Clear Space?	N/A			
	Road X Slope (%)	N/A	N/A	Clear Space to XWalk (in)	N/A			
N/A	Any Obstructions?	N/A	N/A	Storm Grate/Utility Hazard?	N/A			
	Obstruction Type			Storm Grate/Utility Type				
		N/A			N/A			
			Yes	Surface Condition? (G/P)	Good

Remove & Replace Entire Ramp.
