# Access Compliance Report

## Public Rights-of-Way

### (Curb Ramps)

| Intersection ID: 11803 | Main Street: MECKLENBURG_AV | Cross Street: DANIEL_ST | Location: NE |

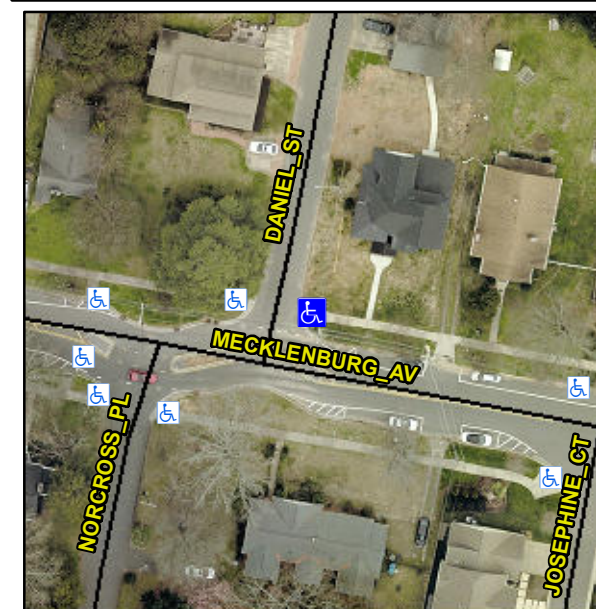
| ADA ID: 2755D8695BFB | Ramp Type: BlendTrans1 | Initial Pass/Fail: Fail | Overall Compliance: No |
| Severity Score: 1.25 | | | |

| Compliance | Description | Data | Compliance | Description | Data |
|---|---|---|---|---|---|
| Yes | Ramp Width (in) | 61.0 | No | BlendTrans XSlope (%) | 4.4 |

**Remove & Replace Curb Ramp With Two New Directional Ramps or Equivalent.**

**R304.5.3**

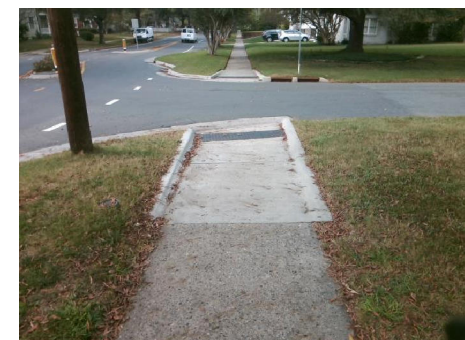
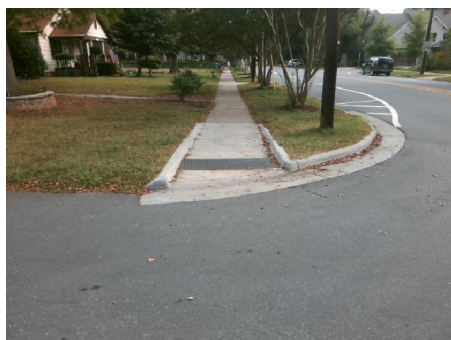
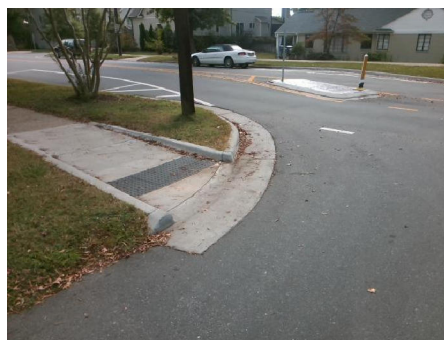
| Compliance | Description | Data | Compliance | Description | Data |
|---|---|---|---|---|---|
| | | | Yes | Surface Condition? (G/P) | Good |
