Access Compliance Report

Public Rights-of-Way

(Curb Ramps)

Intersection ID: 7131	Main Street: N_TRYON_ST	Cross Street: ORCHARD_TRACE_LN	Location: NE
ADA ID: 27575540CDBA	Ramp Type: Perp	Initial Pass/Fail: Pass	Overall Compliance: No
Severity Score: 5			
Codes/Mitigation Info/Possible Solution		Field Measurements/Component Compliance

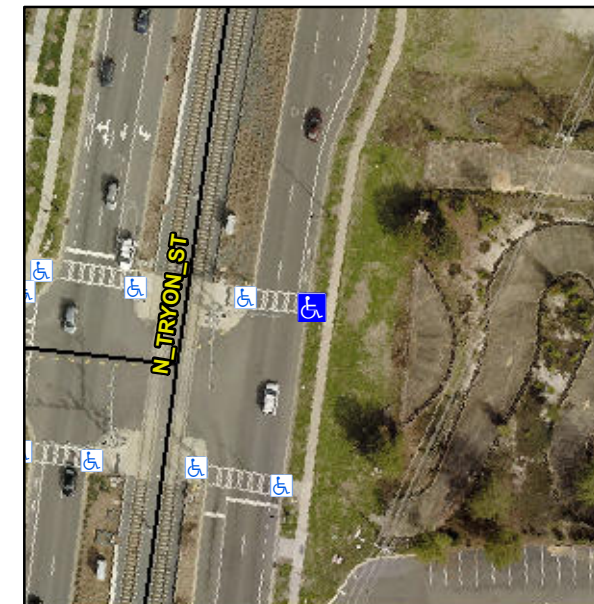
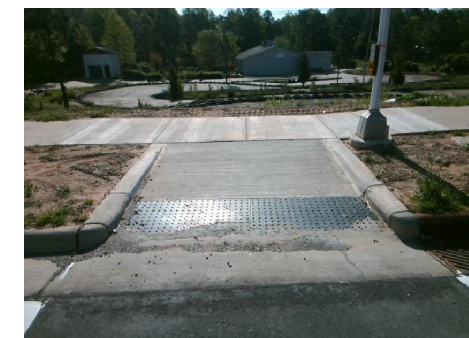
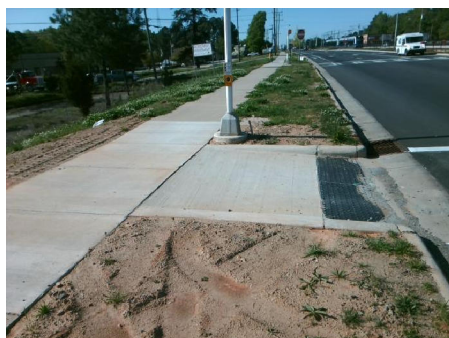
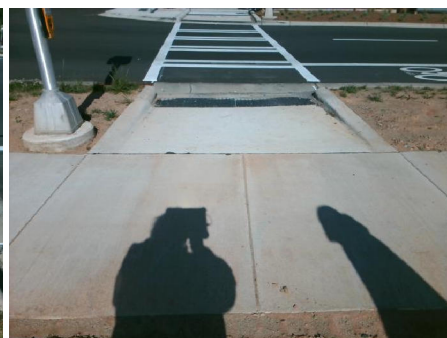
Compliance	Description	Data	Compliance	Description	Data
N/A	Ramp Length (in)	98.0	Yes	Ramp Slope (%)	6.7
Yes	Ramp Width (in)	96.0	Yes	Ramp XSlope (%)	0.6
Yes	Flare Type L	Curbed_NoWalkSurface	Yes	Flare Type RT	N/A
Yes	Flare Slope LT (%)	N/A	N/A	Flare Slope RT (%)	N/A
N/A	Flare Traversable LT?	No	N/A	Flare Traversable RT?	No
Yes	Landing Length (in)	70.0	Yes	DWS Provided?	Yes
Yes	Landing Width (in)	96.0	Yes	DWS Contrast?	Yes
Yes	Landing Slope (%)	0.5	Yes	DWS Length (in)	24.0
Yes	Landing X Slope (%)	0.2	Yes	DWS Full Width?	Yes
N/A	Landing Curb? (Y/N)	No	Yes	DWS Offset (in)	0.0
N/A	Shared Landing?	No			
No	Gutter Ponding?	Yes	No	Gutter Slope (%)	8.7
Yes	Gutter Lip Ht (in)	0.0	Yes	Gutter X Slope (%)	0.9
N/A	Painted X Walk1?	Yes	N/A	Painted X Walk2?	N/A
	X Walk 1 Direction	To W		X Walk 2 Direction	N/A
N/A	X Walk 1 Width (in)	105.0	N/A	X Walk 2 Width (in)	N/A
	X Walk 1 Slope (%)	2.7		X Walk 2 Slope (%)	N/A
	X Walk 1 X Slope (%)	1.3		X Walk 2 X Slope (%)	N/A

Yes	Ramp inside XWalk1?	Yes	N/A	Ramp inside XWalk2?	N/A
	Road Slope (%)	N/A	N/A	Clear Space?	Yes
	Road X Slope (%)	N/A	N/A	Clear Space to XWalk (in)	N/A
Yes	Any Obstructions?	No	Yes	Storm Grate/Utility Hazard?	No
	Obstruction Type			Storm Grate/Utility Type	
		N/A			N/A
			Yes	Surface Condition? (G/P)	Good

Possible Solutions:

Remove & Replace Gutter.

R302.7, R304.5.4
