# Access Compliance Report

## Public Rights-of-Way

### (Curb Ramps)

Intersection ID: 50586	Main Street: LONGSTRAW_RD	Cross Street: DOWNY_BIRCH_RD	Location: SW
ADA ID: 27587FD32BEF	Ramp Type: Perp	Initial Pass/Fail: Pass	Overall Compliance: No
		Severity Score: 5

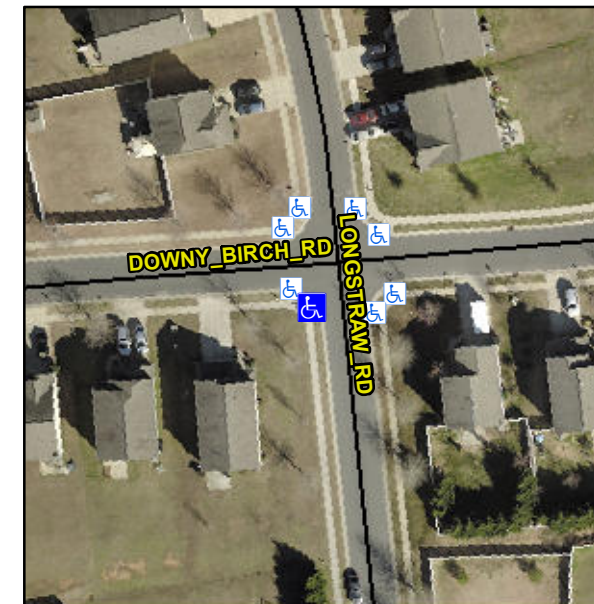
Compliance	Description	Data	Compliance	Description	Data
N/A	Ramp Length (in)	48.5	Yes	Ramp Slope (%)	5.4
Yes	Ramp Width (in)	48.0	Yes	Ramp XSlope (%)	1.1
N/A	Flare Type LT	Sloped	N/A	Flare Type RT	N/A
N/A	Flare Slope LT (%)	2.3	N/A	Flare Slope RT (%)	4.1
N/A	Flare Traversable LT?	No	N/A	Flare Traversable RT?	No
Yes	Landing Length (in)	48.0	Yes	DWS Provided?	Yes
Yes	Landing Width (in)	48.0	Yes	DWS Contrast?	Yes
No	Landing Slope (%)	2.8	Yes	DWS Length (in)	24.5
Yes	Landing X Slope (%)	1.3	Yes	DWS Full Width?	Yes
N/A	Landing Curb? (Y/N)	No	No	DWS Offset (in)	6.5
N/A	Shared Landing?	Yes			
Yes	Gutter Ponding?	No	No	Gutter Slope (%)	13.4
Yes	Gutter Lip Ht (in)	0.0	Yes	Gutter X Slope (%)	1.1
N/A	Painted X Walk1?	No	N/A	Painted X Walk2?	N/A
	X Walk 1 Direction	To E		X Walk 2 Direction	N/A
N/A	X Walk 1 Width (in)	N/A	N/A	X Walk 2 Width (in)	N/A
	X Walk 1 Slope (%)	1.9		X Walk 2 Slope (%)	N/A
	X Walk 1 X Slope (%)	2.4		X Walk 2 X Slope (%)	N/A

N/A	Ramp inside XWalk1?	N/A	N/A	Ramp inside XWalk2?	N/A
	Road Slope (%)	N/A	N/A	Clear Space?	Yes
	Road X Slope (%)	N/A	N/A	Clear Space to XWalk (in)	N/A
Yes	Any Obstructions?	No	Yes	Storm Grate/Utility Hazard?	No
	Obstruction Type			Storm Grate/Utility Type	
		N/A			N/A
			Yes	Surface Condition? (G/P)	Good

Possible Solutions:

**Remove & Replace Entire Ramp.  
Remove & Replace Gutter.**
