# Access Compliance Report

## Public Rights-of-Way

### (Curb Ramps)

Intersection ID: 32079	Main Street: ASHGROVE LN	Cross Street: KEEGAN_WY	Location:	N
ADA ID: 27656F93DA64	Ramp Type: Perp	Initial Pass/Fail: Fail	Overall Compliance: No	Severity Score: 13.75
Codes/Mitigation Info/Possible Solution		Field Measurements/Component Compliance

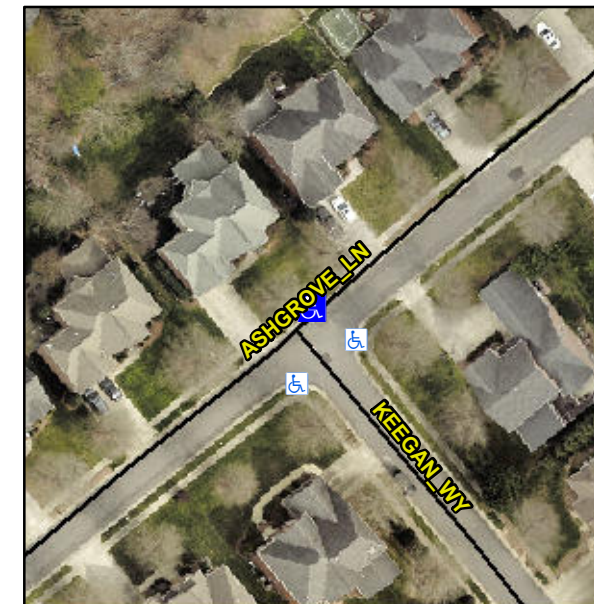
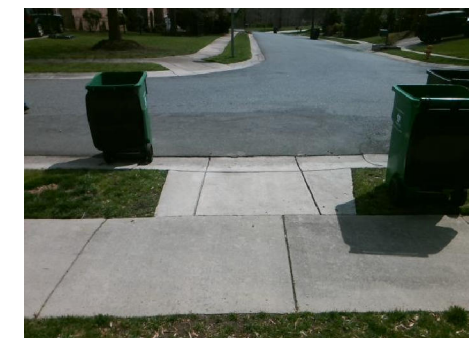
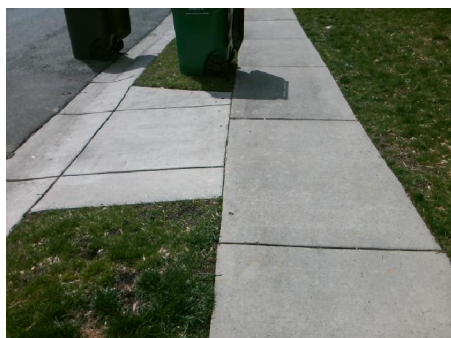
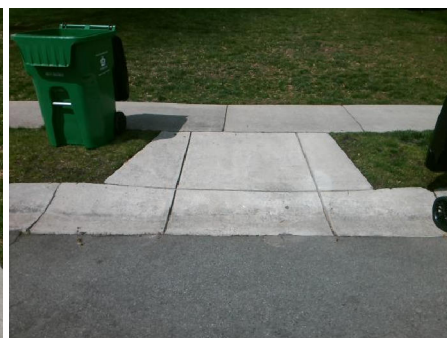
**Not Found, R304.2.2, R304.5.3**

Compliance	Description	Data	Compliance	Description	Data
N/A	Ramp Length (in)	49.0	No	Ramp Slope (%)	9.9
Yes	Ramp Width (in)	48.0	No	Ramp XSlope (%)	4.0
N/A	Flare Type LT	N/A	N/A	Flare Type RT	N/A
N/A	Flare Slope LT (%)	N/A	N/A	Flare Slope RT (%)	N/A
N/A	Flare Traversable LT?	N/A	N/A	Flare Traversable RT?	N/A
N/A	Landing Length (in)	N/A	N/A	DWS Provided?	N/A
N/A	Landing Width (in)	N/A	N/A	DWS Contrast?	N/A
N/A	Landing Slope (%)	N/A	N/A	DWS Length (in)	N/A
N/A	Landing X Slope (%)	N/A	N/A	DWS Full Width?	N/A
N/A	Landing Curb? (Y/N)	N/A	N/A	DWS Offset (in)	N/A
N/A	Shared Landing?	N/A			
N/A	Gutter Ponding?	N/A	N/A	Gutter Slope (%)	N/A
N/A	Gutter Lip Ht (in)	N/A	N/A	Gutter X Slope (%)	N/A
N/A	Painted X Walk1?	No	N/A	Painted X Walk2?	N/A
	X Walk 1 Direction	To SE		X Walk 2 Direction	N/A
N/A	X Walk 1 Width (in)	N/A	N/A	X Walk 2 Width (in)	N/A
	X Walk 1 Slope (%)	1.1		X Walk 2 Slope (%)	N/A
	X Walk 1 X Slope (%)	2.7		X Walk 2 X Slope (%)	N/A

N/A	Ramp inside XWalk1?	N/A	N/A	Ramp inside XWalk2?	N/A
	Road Slope (%)	N/A	N/A	Clear Space?	N/A
	Road X Slope (%)	N/A	N/A	Clear Space to XWalk (in)	N/A
N/A	Any Obstructions?	N/A	N/A	Storm Grate/Utility Hazard?	N/A
	Obstruction Type			Storm Grate/Utility Type	
		N/A			N/A
			Yes	Surface Condition? (G/P)	Good

Possible Solutions:

**Remove & Replace Entire Ramp.**
