# Access Compliance Report

## Public Rights-of-Way

### (Curb Ramps)

| Intersection ID: 17659 | Main Street: CHELTENHAM_RD | Cross Street: WOODLARK_LN | Location: | N |

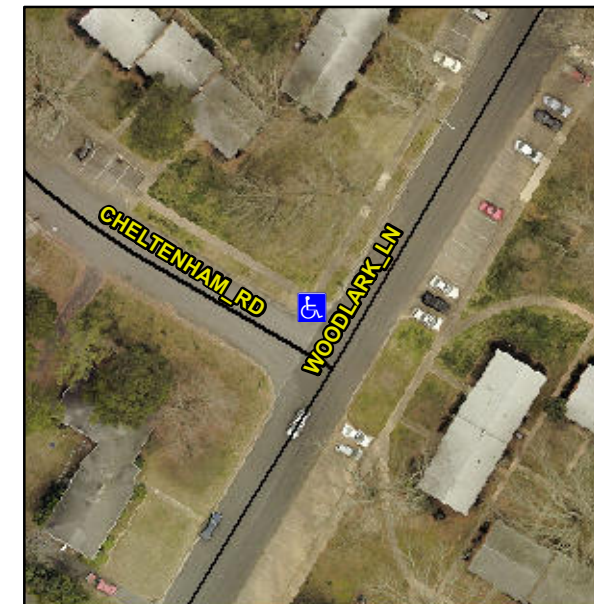
| ADA ID: 276B02BBE754 | Ramp Type: PerpDiag | Initial Pass/Fail: Fail | Overall Compliance: No | Severity Score: 12.5 |

| Compliance | Description | Data | Compliance | Description | Data |
|---|---|---|---|---|---|
| N/A | Ramp Length (in) | 60.0 | No | Ramp Slope (%) | 8.9 |

**Remove & Replace Curb Ramp With Two New Directional Ramps or Equivalent.**

**R304.2.2**
