Access Compliance Report

Public Rights-of-Way

(Curb Ramps)

Intersection ID: 10022282	Main Street: CAMBRIDGE BELTWAY DR	Cross Street: N/A	Location: W
ADA ID: 276BE0D988D8	Ramp Type: PerpDiag	Initial Pass/Fail: Fail	Overall Compliance: No
Codes/Mitigation Info/Possible Solution		Field Measurements/Component Compliance	
Severity Score: 12.5

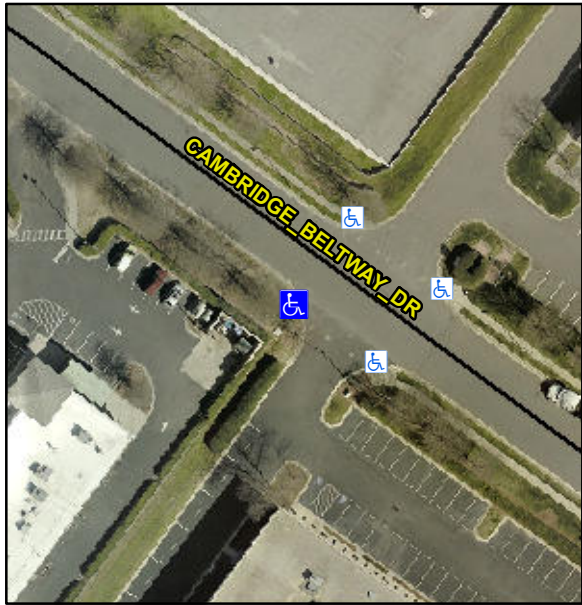
Compliance	Description	Data	Compliance	Description	Data
N/A	Ramp Length (in)	44.0	No	Ramp Slope (%)	9.3
Yes	Ramp Width (in)	48.0	Yes	Ramp XSlope (%)	1.2
N/A	Flare Type LT	N/A	N/A	Flare Type RT	N/A
N/A	Flare Slope LT (%)	N/A	N/A	Flare Slope RT (%)	N/A
N/A	Flare Traversable LT?	N/A	N/A	Flare Traversable RT?	N/A
N/A	Landing Length (in)	N/A	N/A	DWS Provided?	N/A
N/A	Landing Width (in)	N/A	N/A	DWS Contrast?	N/A
N/A	Landing Slope (%)	N/A	N/A	DWS Length (in)	N/A
N/A	Landing X Slope (%)	N/A	N/A	DWS Full Width?	N/A
N/A	Landing Curb? (Y/N)	N/A	N/A	DWS Offset (in)	N/A
N/A	Shared Landing?	N/A			
N/A	Gutter Ponding?	N/A	N/A	Gutter Slope (%)	N/A
N/A	Gutter Lip Ht (in)	N/A	N/A	Gutter X Slope (%)	N/A
N/A	Painted X Walk1?	No	N/A	Painted X Walk2?	No
	X Walk 1 Direction	To SE		X Walk 2 Direction	To NE
N/A	X Walk 1 Width (in)	N/A	N/A	X Walk 2 Width (in)	N/A
	X Walk 1 Slope (%)	0.9		X Walk 2 Slope (%)	3.1
	X Walk 1 X Slope (%)	1.9		X Walk 2 X Slope (%)	1.6

N/A	Ramp inside XWalk1?	N/A	N/A	Ramp inside XWalk2?	N/A
	Road Slope (%)	2.1	N/A	Clear Space?	N/A
	Road X Slope (%)	3.7	N/A	Clear Space to XWalk (in)	N/A
N/A	Any Obstructions?	N/A	N/A	Storm Grate/Utility Hazard?	N/A
	Obstruction Type			Storm Grate/Utility Type	
		N/A			N/A
			Yes	Surface Condition? (G/P)	Good

Possible Solutions:					
	Remove & Replace Curb Ramp With Two New Directional Ramps or Equivalent.					
	Surveyor Notes:					
	N/A					
	PROW/ADA:					
	R304.2.2					
	Street 1 Name		ENTRANCE			
	Stop Condition-Street 2		StopSign			
	Street 2 Name		CAMBRIDGE BELTWAY DR			
	Stop Condition-Street 1		None			
Total Cost:		\$	3200.00
