# Access Compliance Report

## Public Rights-of-Way

### (Curb Ramps)

Intersection ID: 50588	Main Street: BENDING_BRANCH_RD	Cross Street: DOWNY_BIRCH_RD	Location: NE
ADA ID: 27804BEB43CD	Ramp Type: Perp	Initial Pass/Fail: Fail	Overall Compliance: No
Severity Score: 22.5			
Codes/Mitigation Info/Possible Solution		Field Measurements/Component Compliance

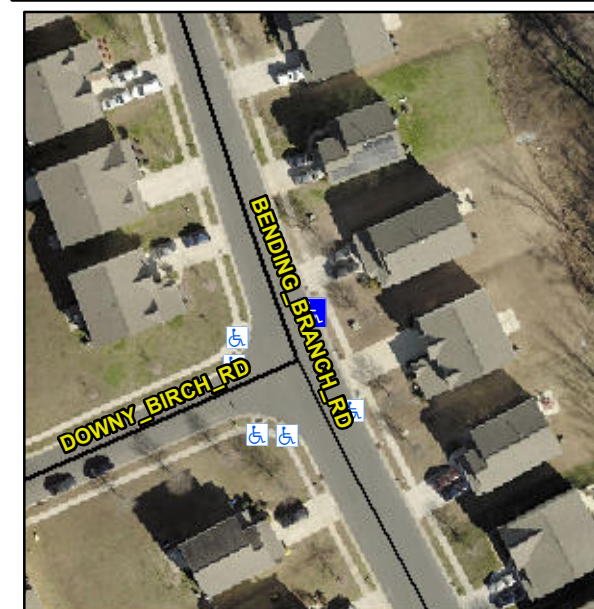
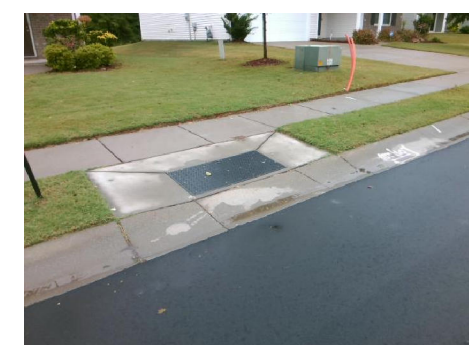
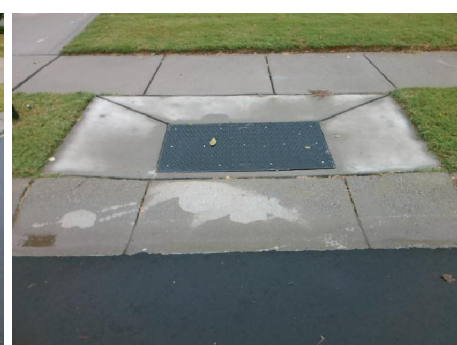
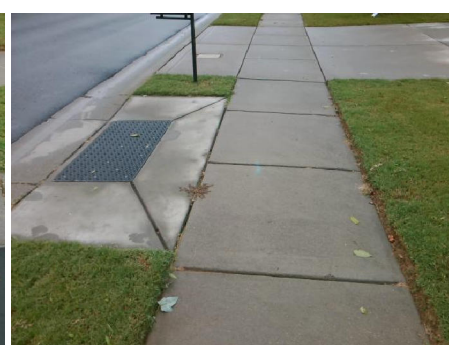
**Not Found, R304.5.1, R304.2.2, R304.5.3**

Compliance	Description	Data	Compliance	Description	Data
N/A	Ramp Length (in)	46.5	No	Ramp Slope (%)	10.4
No	Ramp Width (in)	47.5	No	Ramp XSlope (%)	3.2
N/A	Flare Type LT	N/A	N/A	Flare Type RT	N/A
N/A	Flare Slope LT (%)	N/A	N/A	Flare Slope RT (%)	N/A
N/A	Flare Traversable LT?	N/A	N/A	Flare Traversable RT?	N/A
N/A	Landing Length (in)	N/A	N/A	DWS Provided?	N/A
N/A	Landing Width (in)	N/A	N/A	DWS Contrast?	N/A
N/A	Landing Slope (%)	N/A	N/A	DWS Length (in)	N/A
N/A	Landing X Slope (%)	N/A	N/A	DWS Full Width?	N/A
N/A	Landing Curb? (Y/N)	N/A	N/A	DWS Offset (in)	N/A
N/A	Shared Landing?	N/A			
N/A	Gutter Ponding?	N/A	N/A	Gutter Slope (%)	N/A
N/A	Gutter Lip Ht (in)	N/A	N/A	Gutter X Slope (%)	N/A
N/A	Painted X Walk1?	No	N/A	Painted X Walk2?	N/A
	X Walk 1 Direction	To E		X Walk 2 Direction	N/A
N/A	X Walk 1 Width (in)	N/A	N/A	X Walk 2 Width (in)	N/A
	X Walk 1 Slope (%)	2.2		X Walk 2 Slope (%)	N/A
	X Walk 1 X Slope (%)	2.0		X Walk 2 X Slope (%)	N/A

N/A	Ramp inside XWalk1?	N/A	N/A	Ramp inside XWalk2?	N/A
	Road Slope (%)	N/A	N/A	Clear Space?	N/A
	Road X Slope (%)	N/A	N/A	Clear Space to XWalk (in)	N/A
N/A	Any Obstructions?	N/A	N/A	Storm Grate/Utility Hazard?	N/A
	Obstruction Type			Storm Grate/Utility Type	
		N/A			N/A
			Yes	Surface Condition? (G/P)	Good

**Remove & Replace Entire Ramp.**
