Access Compliance Report

Public Rights-of-Way

(Curb Ramps)

Intersection ID: 8858	Main Street: BROOKSTEAD_DR	Cross Street: NORKETT_DR	Location:	N
ADA ID: 2789B9F4EFBE	Ramp Type: Perp	Initial Pass/Fail: Fail	Overall Compliance: No	Severity Score: 8.75
Codes/Mitigation Info/Possible Solution		Field Measurements/Component Compliance

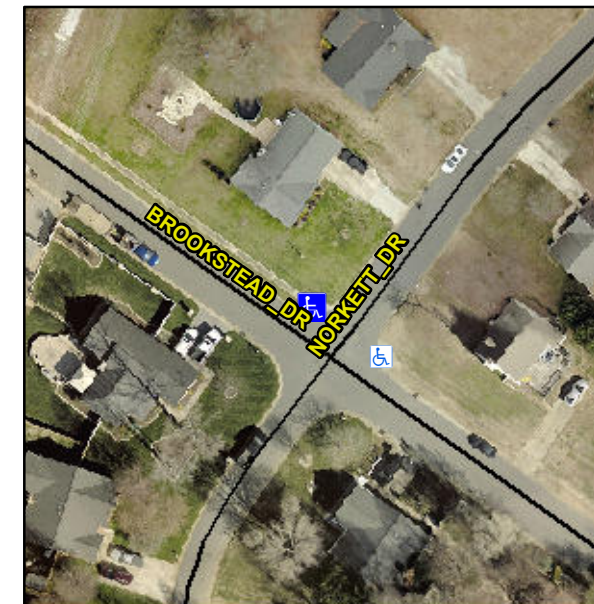
Compliance	Description	Data	Compliance	Description	Data
N/A	Ramp Length (in)	61.5	Yes	Ramp Slope (%)	6.4
No	Ramp Width (in)	47.5	Yes	Ramp XSlope (%)	1.7
N/A	Flare Type LT	N/A	N/A	Flare Type RT	N/A
N/A	Flare Slope LT (%)	N/A	N/A	Flare Slope RT (%)	N/A
N/A	Flare Traversable LT?	N/A	N/A	Flare Traversable RT?	N/A
N/A	Landing Length (in)	N/A	N/A	DWS Provided?	N/A
N/A	Landing Width (in)	N/A	N/A	DWS Contrast?	N/A
N/A	Landing Slope (%)	N/A	N/A	DWS Length (in)	N/A
N/A	Landing X Slope (%)	N/A	N/A	DWS Full Width?	N/A
N/A	Landing Curb? (Y/N)	N/A	N/A	DWS Offset (in)	N/A
N/A	Shared Landing?	N/A			
N/A	Gutter Ponding?	N/A	N/A	Gutter Slope (%)	N/A
N/A	Gutter Lip Ht (in)	N/A	N/A	Gutter X Slope (%)	N/A
N/A	Painted X Walk1?	No	N/A	Painted X Walk2?	N/A
	X Walk 1 Direction	To SE		X Walk 2 Direction	N/A
N/A	X Walk 1 Width (in)	N/A	N/A	X Walk 2 Width (in)	N/A
	X Walk 1 Slope (%)	2.6		X Walk 2 Slope (%)	N/A
	X Walk 1 X Slope (%)	0.3		X Walk 2 X Slope (%)	N/A

Possible Solutions:

Remove & Replace Entire Ramp.

R304.5.1

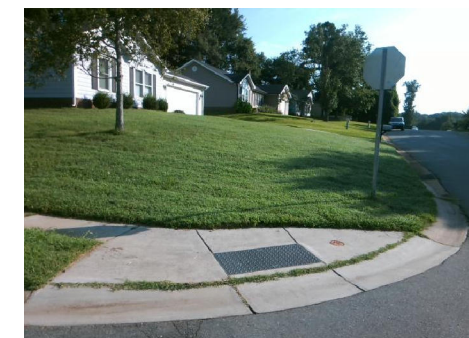
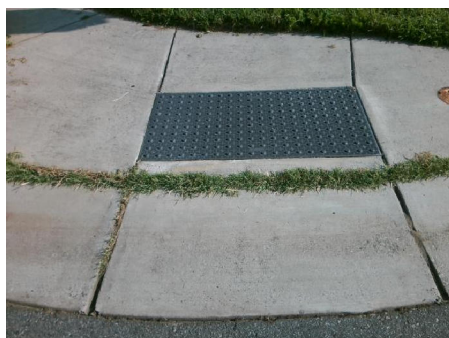
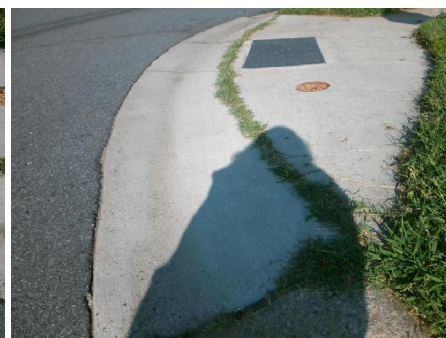
N/A	Ramp inside XWalk1?	N/A	N/A	Ramp inside XWalk2?	N/A
	Road Slope (%)	N/A	N/A	Clear Space?	N/A
	Road X Slope (%)	N/A	N/A	Clear Space to XWalk (in)	N/A
N/A	Any Obstructions?	N/A	N/A	Storm Grate/Utility Hazard?	N/A
	Obstruction Type			Storm Grate/Utility Type	
		N/A			N/A
			Yes	Surface Condition? (G/P)	Good

Street 1 Name **NORKETT DR**
 Stop Condition-Street 2 **StopSign**
 Street 2 Name **N/A**
 Stop Condition-Street 1 **N/A**
