# Access Compliance Report

## Public Rights-of-Way

### (Curb Ramps)

| Intersection ID: 10527 | Main Street: PARKWAY_AV | Cross Street: TUCKASEEGEE_RD | Location: SE |

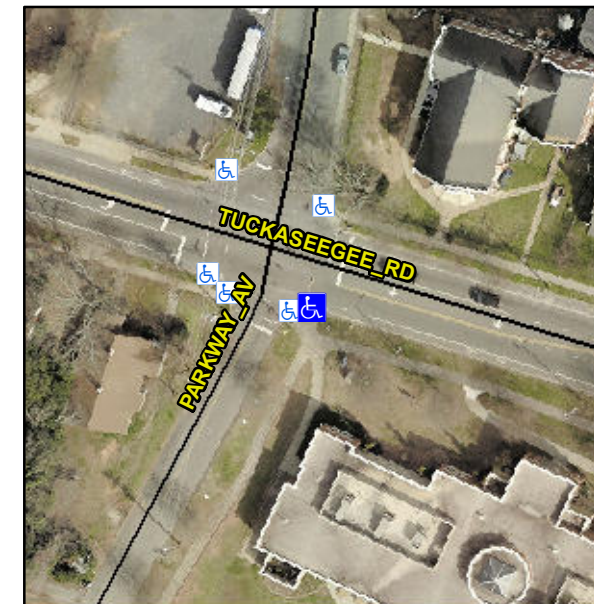
| ADA ID: 279C916B28C0 | Ramp Type: Perp | Initial Pass/Fail: Pass | Overall Compliance: No |
| Severity Score: 2.75 | | | |

**R304.2.1, R304.5.3, R305.1.4, R305.2**

| Compliance | Description | Data | Compliance | Description | Data |
|---|---|---|---|---|---|
| No | Landing Length (in) | 46.0 | Yes | DWS Provided? | Yes |
| No | Landing X Slope (%) | 3.5 | No | DWS Full Width? | No |
| N/A | Landing Curb? (Y/N) | No | No | DWS Offset (in) | 2.5 |

**Remove & Replace Entire Ramp.**

Total Cost: \$ 1850.00
