Access Compliance Report

Public Rights-of-Way

(Curb Ramps)

Intersection ID: 30232	Main Street: CLARA_DUNN_LN	Cross Street: MCGINN_GROVE_DR	Location:	S
ADA ID: 279EEC591360	Ramp Type: PerpDiag	Initial Pass/Fail: Fail	Overall Compliance: No	Severity Score: 21.25
Codes/Mitigation Info/Possible Solution		Field Measurements/Component Compliance

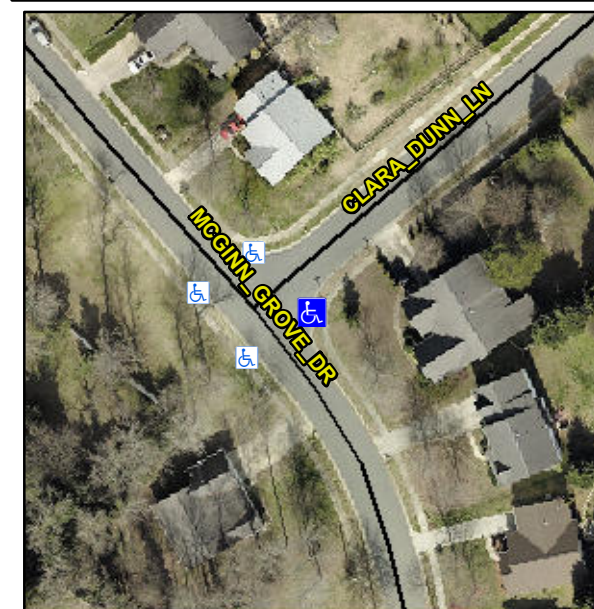
PROW/ADA:

Not Found, R304.5.1, R304.5.3

Compliance	Description	Data	Compliance	Description	Data
N/A	Ramp Length (in)	47.5	Yes	Ramp Slope (%)	5.0
No	Ramp Width (in)	43.0	No	Ramp XSlope (%)	6.8
N/A	Flare Type LT	N/A	N/A	Flare Type RT	N/A
N/A	Flare Slope LT (%)	N/A	N/A	Flare Slope RT (%)	N/A
N/A	Flare Traversable LT?	N/A	N/A	Flare Traversable RT?	N/A
N/A	Landing Length (in)	N/A	N/A	DWS Provided?	N/A
N/A	Landing Width (in)	N/A	N/A	DWS Contrast?	N/A
N/A	Landing Slope (%)	N/A	N/A	DWS Length (in)	N/A
N/A	Landing X Slope (%)	N/A	N/A	DWS Full Width?	N/A
N/A	Landing Curb? (Y/N)	N/A	N/A	DWS Offset (in)	N/A
N/A	Shared Landing?	N/A			
N/A	Gutter Ponding?	N/A	N/A	Gutter Slope (%)	N/A
N/A	Gutter Lip Ht (in)	0.5	N/A	Gutter X Slope (%)	N/A
N/A	Painted X Walk1?	No	N/A	Painted X Walk2?	No
	X Walk 1 Direction	To NE		X Walk 2 Direction	To NW
N/A	X Walk 1 Width (in)	N/A	N/A	X Walk 2 Width (in)	N/A
	X Walk 1 Slope (%)	0.7		X Walk 2 Slope (%)	3.2
	X Walk 1 X Slope (%)	5.5		X Walk 2 X Slope (%)	3.1

N/A	Ramp inside XWalk1?	N/A	N/A	Ramp inside XWalk2?	N/A
	Road Slope (%)	4.1	N/A	Clear Space?	N/A
	Road X Slope (%)	4.3	N/A	Clear Space to XWalk (in)	N/A
N/A	Any Obstructions?	N/A	N/A	Storm Grate/Utility Hazard?	N/A
	Obstruction Type			Storm Grate/Utility Type	
		N/A			N/A
			Yes	Surface Condition? (G/P)	Good

Possible Solutions:

Remove & Replace Curb Ramp With Two New Directional Ramps or Equivalent.

Total Cost: \$ 3200.00
