# Access Compliance Report

## Public Rights-of-Way

### (Curb Ramps)

Intersection ID: 15083	Main Street: SHEFFIELD_DR	Cross Street: WOODLAND_DR	Location: NE
ADA ID: 27A0074BCAED	Ramp Type: BlendTrans1	Initial Pass/Fail: Fail	Overall Compliance: No
		Severity Score: 12.5

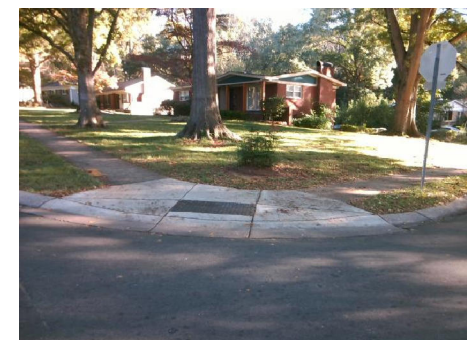
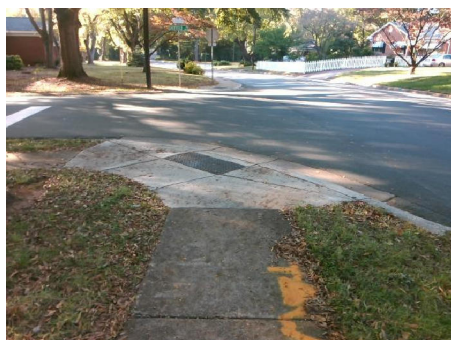
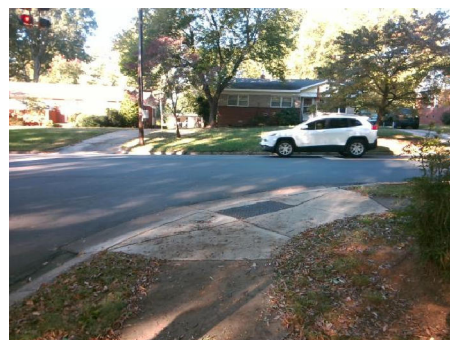
N/A	Painted X Walk1?	No	N/A	Painted X Walk2?	N/A
				X Walk 1 Direction	To S		X Walk 2 Direction	N/A
				X Walk 1 Width (in)	N/A		X Walk 2 Width (in)	N/A
				X Walk 1 Slope (%)	1.2		X Walk 2 Slope (%)	N/A
				X Walk 1 X Slope (%)	2.6		X Walk 2 X Slope (%)	N/A
			N/A	Ramp inside XWalk1?	N/A	N/A	Ramp inside XWalk2?	N/A
			Road Slope (%)	2.6		Clear Space?	N/A	
			Road X Slope (%)	1.2	N/A	Clear Space to XWalk (in)	N/A	
		N/A	Any Obstructions?	N/A	N/A	Storm Grate/Utility Hazard?	N/A	
			Obstruction Type			Storm Grate/Utility Type		
					N/A			N/A
					Yes	Surface Condition? (G/P)	Good	
					No	Curb Slope (%)	21.5

Possible Solutions:		Compliance	Description	Data	Compliance	Description	Data
	Remove & Replace Curb Ramp With Two New Directional Ramps or Equivalent.		N/A	Ramp Length (in)	74.0	Yes	BlendTrans Slope (%)	4.4
			Yes	Ramp Width (in)	48.0	No	BlendTrans XSlope (%)	5.8
			N/A	Flare Type LT	N/A	N/A	Flare Type RT	N/A
			N/A	Flare Slope LT (%)	N/A	N/A	Flare Slope RT (%)	N/A
			N/A	Flare Traversable LT?	N/A	N/A	Flare Traversable RT?	N/A
			N/A	Landing Length (in)	N/A	N/A	DWS Provided?	N/A
			N/A	Landing Width (in)	N/A	N/A	DWS Contrast?	N/A
			N/A	Landing Slope (%)	N/A	N/A	DWS Length (in)	N/A
			N/A	Landing X Slope (%)	N/A	N/A	DWS Full Width?	N/A
Surveyor Notes:	N/A		N/A	Landing Curb? (Y/N)	N/A	N/A	DWS Offset (in)	N/A
			N/A	Shared Landing?	N/A			
	PROW/ADA:		N/A	Gutter Ponding?	N/A	N/A	Gutter Slope (%)	N/A
	Not Found, R304.5.3		N/A	Gutter Lip Ht (in)	N/A	N/A	Gutter X Slope (%)	N/A
