# Access Compliance Report

## Public Rights-of-Way

### (Curb Ramps)

Intersection ID: 22532	Main Street: HARRISON_RD	Cross Street: HARRISONWOODS_PL	Location: SW
ADA ID: 27A18A8C5705	Ramp Type: PerpDiag	Initial Pass/Fail: Fail	Overall Compliance: No
Severity Score: 25			
Codes/Mitigation Info/Possible Solution		Field Measurements/Component Compliance

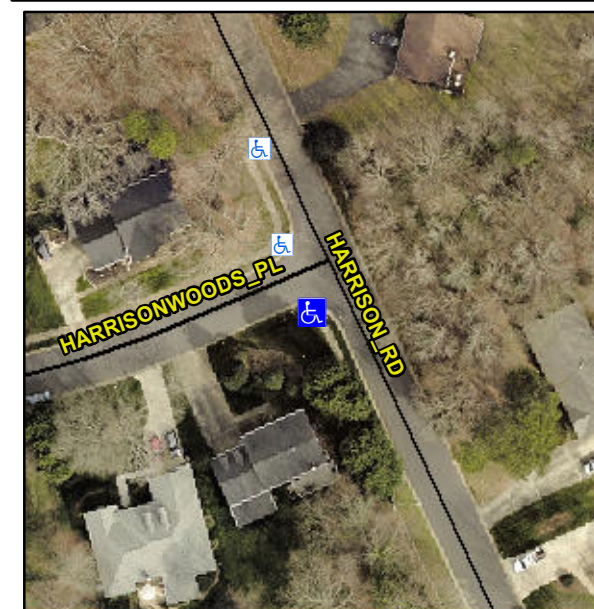
**Not Found, R304.5.3**

Compliance	Description	Data	Compliance	Description	Data
N/A	Ramp Length (in)	97.0	Yes	Ramp Slope (%)	6.2
Yes	Ramp Width (in)	76.0	No	Ramp XSlope (%)	7.5
N/A	Flare Type LT	N/A	N/A	Flare Type RT	N/A
N/A	Flare Slope LT (%)	N/A	N/A	Flare Slope RT (%)	N/A
N/A	Flare Traversable LT?	N/A	N/A	Flare Traversable RT?	N/A
N/A	Landing Length (in)	N/A	N/A	DWS Provided?	N/A
N/A	Landing Width (in)	N/A	N/A	DWS Contrast?	N/A
N/A	Landing Slope (%)	N/A	N/A	DWS Length (in)	N/A
N/A	Landing X Slope (%)	N/A	N/A	DWS Full Width?	N/A
N/A	Landing Curb? (Y/N)	N/A	N/A	DWS Offset (in)	N/A
N/A	Shared Landing?	N/A			
N/A	Gutter Ponding?	N/A	N/A	Gutter Slope (%)	N/A
N/A	Gutter Lip Ht (in)	N/A	N/A	Gutter X Slope (%)	N/A
N/A	Painted X Walk1?	No	N/A	Painted X Walk2?	No
	X Walk 1 Direction	To NE		X Walk 2 Direction	To NW
N/A	X Walk 1 Width (in)	N/A	N/A	X Walk 2 Width (in)	N/A
	X Walk 1 Slope (%)	10.8		X Walk 2 Slope (%)	3.5
	X Walk 1 X Slope (%)	0.2		X Walk 2 X Slope (%)	5.9

N/A	Ramp inside XWalk1?	N/A	N/A	Ramp inside XWalk2?	N/A
	Road Slope (%)	3.5	N/A	Clear Space?	N/A
	Road X Slope (%)	6.0	N/A	Clear Space to XWalk (in)	N/A
N/A	Any Obstructions?	N/A	N/A	Storm Grate/Utility Hazard?	N/A
	Obstruction Type			Storm Grate/Utility Type	
		N/A			N/A
		Yes		Surface Condition? (G/P)	Good

**Remove & Replace Curb Ramp With Two New Directional Ramps or Equivalent.**

Total Cost: \$ 3200.00
