# Access Compliance Report

## Public Rights-of-Way

### (Curb Ramps)

Intersection ID: 19152	Main Street: E_INDEPENDENCE_BV	Cross Street: VILLAGE_LAKE_DR	Location: W
ADA ID: 27B68E4F2E70	Ramp Type: PerpDiag	Initial Pass/Fail: Fail	Overall Compliance: No
		Severity Score: 25

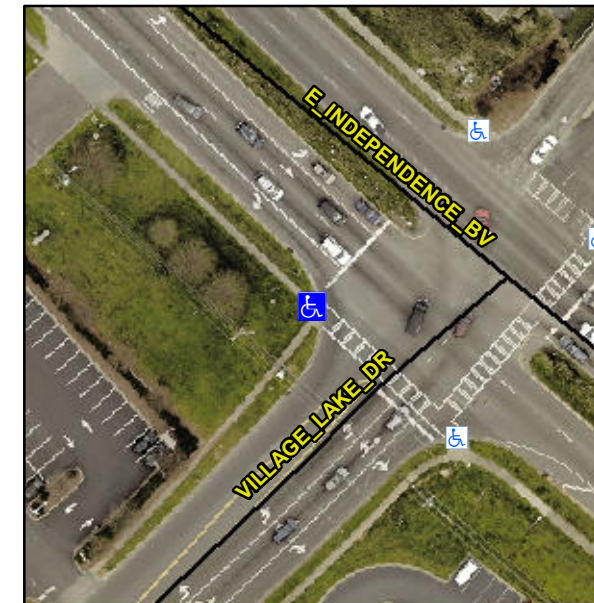
Compliance	Description	Data	Compliance	Description	Data
N/A	Ramp Length (in)	48.0	No	Ramp Slope (%)	18.7
Yes	Ramp Width (in)	48.0	Yes	Ramp XSlope (%)	1.3
N/A	Flare Type LT	N/A	N/A	Flare Type RT	N/A
N/A	Flare Slope LT (%)	N/A	N/A	Flare Slope RT (%)	N/A
N/A	Flare Traversable LT?	N/A	N/A	Flare Traversable RT?	N/A
N/A	Landing Length (in)	N/A	N/A	DWS Provided?	N/A
N/A	Landing Width (in)	N/A	N/A	DWS Contrast?	N/A
N/A	Landing Slope (%)	N/A	N/A	DWS Length (in)	N/A
N/A	Landing X Slope (%)	N/A	N/A	DWS Full Width?	N/A
N/A	Landing Curb? (Y/N)	N/A	N/A	DWS Offset (in)	N/A
N/A	Shared Landing?	N/A			
N/A	Gutter Ponding?	N/A	N/A	Gutter Slope (%)	N/A
N/A	Gutter Lip Ht (in)	N/A	N/A	Gutter X Slope (%)	N/A
N/A	Painted X Walk1?	Yes	N/A	Painted X Walk2?	No
	X Walk 1 Direction	To SE		X Walk 2 Direction	To NE
N/A	X Walk 1 Width (in)	108.0	N/A	X Walk 2 Width (in)	N/A
	X Walk 1 Slope (%)	0.7		X Walk 2 Slope (%)	2.3
	X Walk 1 X Slope (%)	2.9		X Walk 2 X Slope (%)	1.5

N/A	Ramp inside XWalk1?	Yes	N/A	Ramp inside XWalk2?	N/A
	Road Slope (%)	3.3	N/A	Clear Space?	N/A
	Road X Slope (%)	1.4	N/A	Clear Space to XWalk (in)	N/A
N/A	Any Obstructions?	N/A	N/A	Storm Grate/Utility Hazard?	N/A
	Obstruction Type			Storm Grate/Utility Type	
		N/A			N/A
		Yes		Surface Condition? (G/P)	Good

**Remove & Replace Curb Ramp With Two New Directional Ramps or Equivalent.**

**R304.2.2**
