# Access Compliance Report

## Public Rights-of-Way

### (Curb Ramps)

Intersection ID: 7812	Main Street: SQUIRREL_HILL_RD	Cross Street: THORNWOOD_RD	Location:	N
ADA ID: 27BF207A2A84	Ramp Type: BlendTrans2	Initial Pass/Fail: Fail	Overall Compliance: No	Severity Score: 1.25
Codes/Mitigation Info/Possible Solution		Field Measurements/Component Compliance

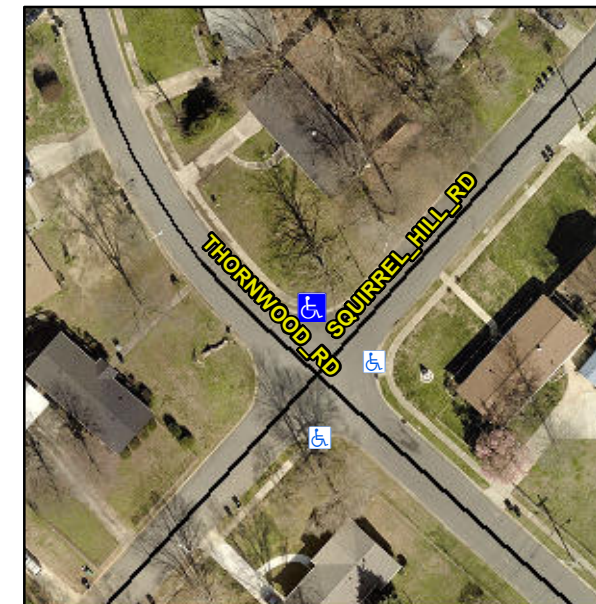
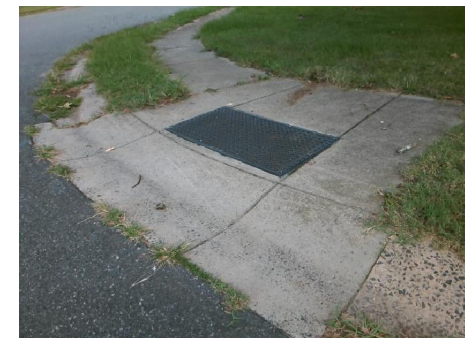
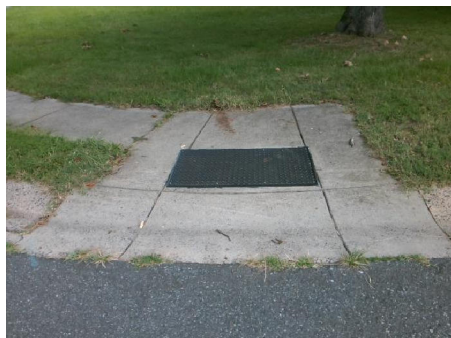
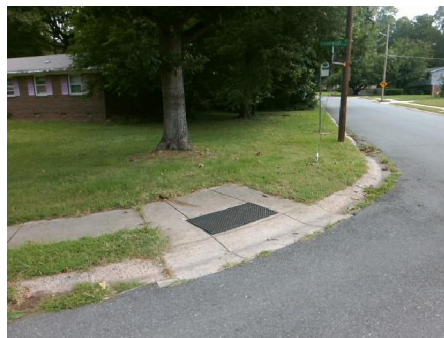
**NO RT SW**

**Not Found, R304.5.3**

Compliance	Description	Data	Compliance	Description	Data
N/A	Ramp Length (in)	72.0	Yes	BlendTrans Slope (%)	4.1
Yes	Ramp Width (in)	49.5	No	BlendTrans XSlope (%)	2.2
N/A	Flare Type LT	Sloped	N/A	Flare Type RT	Sloped
N/A	Flare Slope LT (%)	2.4	N/A	Flare Slope RT (%)	5.8
N/A	Flare Traversable LT?	No	N/A	Flare Traversable RT?	No
N/A	Landing Length (in)	N/A	N/A	DWS Provided?	Yes
N/A	Landing Width (in)	N/A	N/A	DWS Contrast?	Yes
N/A	Landing Slope (%)	N/A	N/A	DWS Length (in)	25.5
N/A	Landing X Slope (%)	N/A	N/A	DWS Full Width?	Yes
N/A	Landing Curb? (Y/N)	Yes	N/A	DWS Offset (in)	2.5
N/A	Shared Landing?	No			
N/A	Gutter Ponding?	No	N/A	Gutter Slope (%)	15.0
N/A	Gutter Lip Ht (in)	0.3	N/A	Gutter X Slope (%)	0.8
N/A	Painted X Walk1?	No	N/A	Painted X Walk2?	N/A
	X Walk 1 Direction	To SE		X Walk 2 Direction	N/A
	X Walk 1 Width (in)	N/A		X Walk 2 Width (in)	N/A
	X Walk 1 Slope (%)	2.1		X Walk 2 Slope (%)	N/A
	X Walk 1 X Slope (%)	0.2		X Walk 2 X Slope (%)	N/A

N/A	Ramp inside XWalk1?	N/A	N/A	Ramp inside XWalk2?	N/A
	Road Slope (%)	0.2		Clear Space?	Yes
	Road X Slope (%)	2.1	N/A	Clear Space to XWalk (in)	N/A
N/A	Any Obstructions?	No	N/A	Storm Grate/Utility Hazard?	No
	Obstruction Type			Storm Grate/Utility Type	
		N/A			N/A
			Yes	Surface Condition? (G/P)	Good
			No	Curb Slope (%)	15.4

**Remove & Replace Curb Ramp With Two New Directional Ramps or Equivalent.**
