# Access Compliance Report

## Public Rights-of-Way

### (Curb Ramps)

| Intersection ID: 47854 | Main Street: ADOBE_RD | Cross Street: CACTUS_VALLEY_RD | Location: SW |

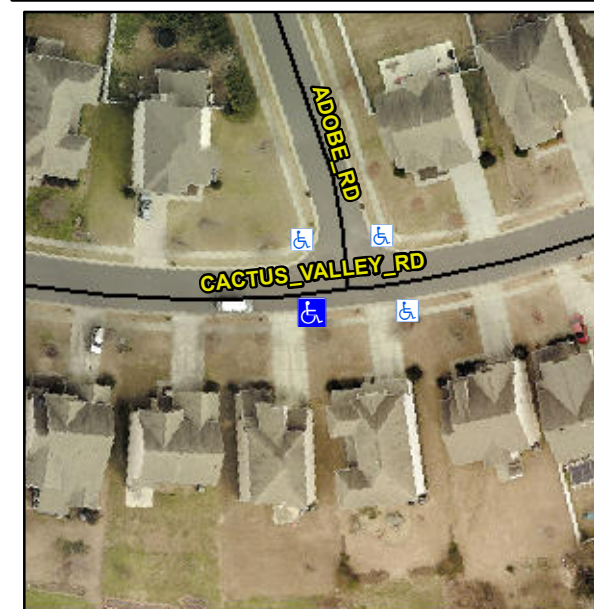
**Not Found, R304.2.2**

| Compliance | Description | Data | Compliance | Description | Data |
|---|---|---|---|---|---|
| N/A | Ramp Length (in) | 47.0 | No | Ramp Slope (%) | 8.8 |

**Remove & Replace Entire Ramp.**

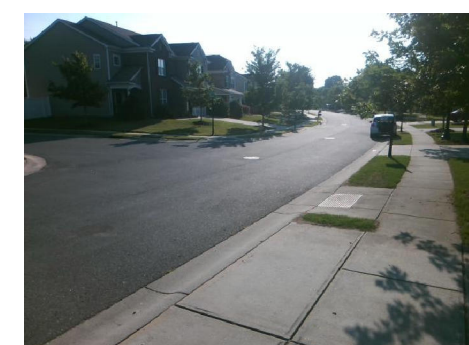
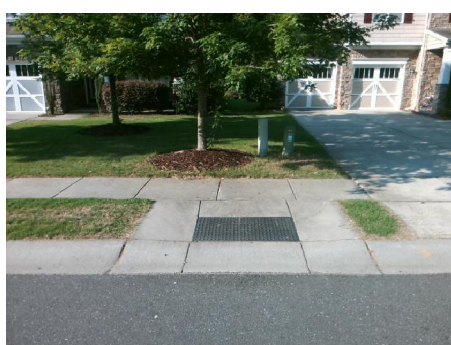
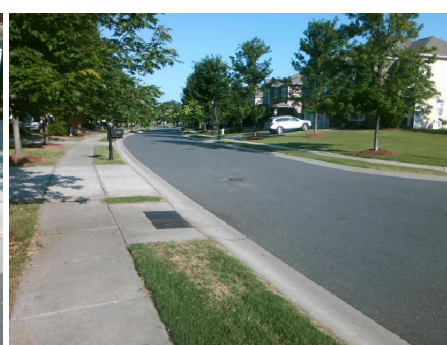
| Compliance | Description | Data | Compliance | Description | Data |
|---|---|---|---|---|---|
| | | | Yes | Surface Condition? (G/P) | Good |
