# Access Compliance Report

## Public Rights-of-Way

### (Curb Ramps)

Intersection ID: 12711	Main Street: E_STONEWALL_ST	Cross Street: S_TRYON_ST	Location: E
ADA ID: 27CC271C39D8	Ramp Type: Perp	Initial Pass/Fail: Fail	Overall Compliance: No
			Severity Score: 13.75

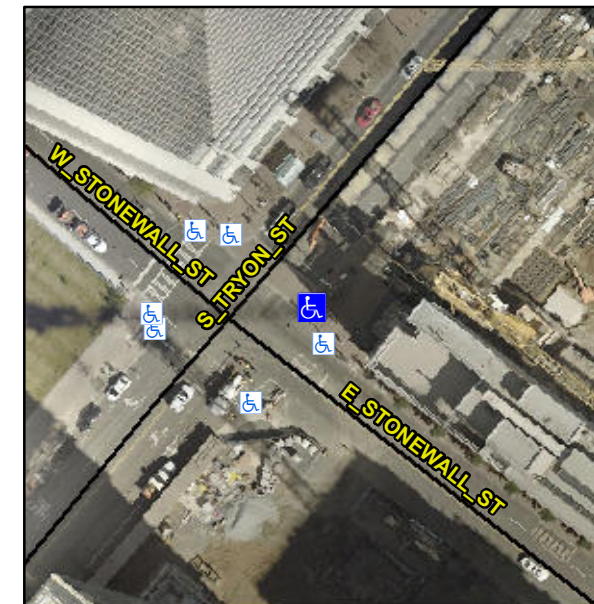
Compliance	Description	Data	Compliance	Description	Data
N/A	Ramp Length (in)	43.0	No	Ramp Slope (%)	11.1
Yes	Ramp Width (in)	60.0	No	Ramp XSlope (%)	2.3
N/A	Flare Type LT	N/A	N/A	Flare Type RT	N/A
N/A	Flare Slope LT (%)	N/A	N/A	Flare Slope RT (%)	N/A
N/A	Flare Traversable LT?	N/A	N/A	Flare Traversable RT?	N/A
N/A	Landing Length (in)	N/A	N/A	DWS Provided?	N/A
N/A	Landing Width (in)	N/A	N/A	DWS Contrast?	N/A
N/A	Landing Slope (%)	N/A	N/A	DWS Length (in)	N/A
N/A	Landing X Slope (%)	N/A	N/A	DWS Full Width?	N/A
N/A	Landing Curb? (Y/N)	N/A	N/A	DWS Offset (in)	N/A
N/A	Shared Landing?	N/A			
N/A	Gutter Ponding?	N/A	N/A	Gutter Slope (%)	N/A
N/A	Gutter Lip Ht (in)	N/A	N/A	Gutter X Slope (%)	N/A
N/A	Painted X Walk1?	Yes	N/A	Painted X Walk2?	N/A
	X Walk 1 Direction	To NW		X Walk 2 Direction	N/A
N/A	X Walk 1 Width (in)	145.0	N/A	X Walk 2 Width (in)	N/A
	X Walk 1 Slope (%)	6.4		X Walk 2 Slope (%)	N/A
	X Walk 1 X Slope (%)	1.2		X Walk 2 X Slope (%)	N/A

N/A	Ramp inside XWalk1?	Yes	N/A	Ramp inside XWalk2?	N/A
	Road Slope (%)	N/A	N/A	Clear Space?	N/A
	Road X Slope (%)	N/A	N/A	Clear Space to XWalk (in)	N/A
N/A	Any Obstructions?	N/A	N/A	Storm Grate/Utility Hazard?	N/A
	Obstruction Type			Storm Grate/Utility Type	
		N/A			N/A
			Yes	Surface Condition? (G/P)	Good

**Remove & Replace Entire Ramp.**

**R304.2.2, R304.5.3**
