# Access Compliance Report

## Public Rights-of-Way

### (Curb Ramps)

Intersection ID: 19933	Main Street: CARNEGIE_BV	Cross Street: CONGRESS_ST	Location: SE
ADA ID: 27CF81266DA8	Ramp Type: Directional1	Initial Pass/Fail: Fail	Overall Compliance: No
		Severity Score: 1.25

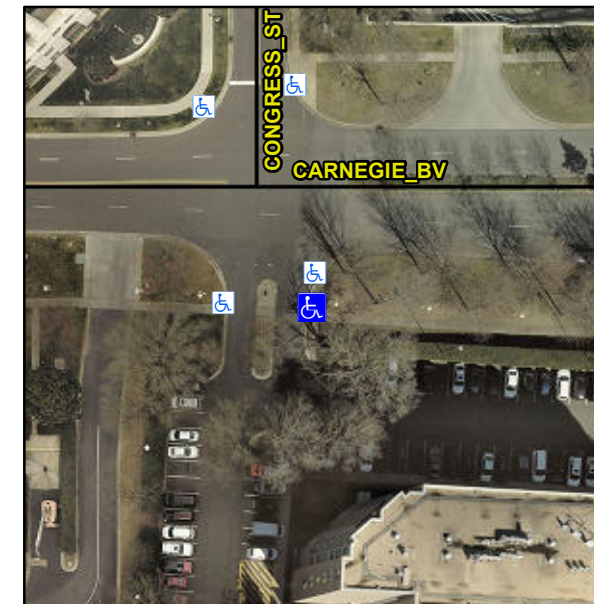
**R304.5.3**

Compliance	Description	Data	Compliance	Description	Data
N/A	Ramp Length (in)	63.0	N/A	Grade Break?	N/A
Yes	Ramp Width (in)	59.0	N/A	Grade Break Slope (%)	0.0
Yes	Ramp Slope (%)	2.0	N/A	Grade Break XSlope (%)	0.0
No	Ramp XSlope (%)	3.5			
N/A	Flare Type LT	N/A	N/A	Flare Type RT	N/A
N/A	Flare Slope LT (%)	N/A	N/A	Flare Slope RT (%)	0.0
N/A	Flare Traversable LT?	N/A	N/A	Flare Traversable RT?	N/A
N/A	Landing Length (in)	0.0	N/A	DWS Provided?	N/A
N/A	Landing Width (in)	0.0	N/A	DWS Contrast?	N/A
N/A	Landing Slope (%)	0.0	N/A	DWS Length (in)	N/A
N/A	Landing X Slope (%)	0.0	N/A	DWS Full Width?	N/A
N/A	Landing Curb? (Y/N)	N/A	N/A	DWS Offset LT (in)	N/A
N/A	Shared Landing?	N/A	N/A	DWS Offset RT (in)	N/A
N/A	Gutter Ponding?	0.0	N/A	Gutter Slope (%)	N/A
N/A	Gutter Lip Ht (in)	0.0	N/A	Gutter X Slope (%)	N/A
N/A	Painted X Walk1?	No		Road Slope (%)	1.0
	X Walk 1 Direction	To W		Road X Slope (%)	4.4
	X Walk 1 Width (in)	N/A		Clear Space?	N/A

X Walk 1 Slope (%)	1.0	N/A	Clear Space to XWalk (in)	N/A
	X Walk 1 X Slope (%)	4.4	N/A	Storm Grate/Utility Hazard?	N/A
N/A	Ramp inside XWalk1?	N/A		Storm Grate/Utility Type	
N/A	Any Obstructions?	N/A			N/A
	Obstruction Type		Yes	Surface Condition? (G/P)	Good
			N/A	Curb Slope (%)	13.6

**Remove & Replace Entire Ramp.**
