Intersection ID: 19457	Main Street: S_TRYON_ST	Cross Street: YORKDALE_DR	Location:	SE
ADA ID: 27DAAD2C933B	Ramp Type: Perp	Initial Pass/Fail: Fail	Overall Compliance: No	Severity Score: 13.75

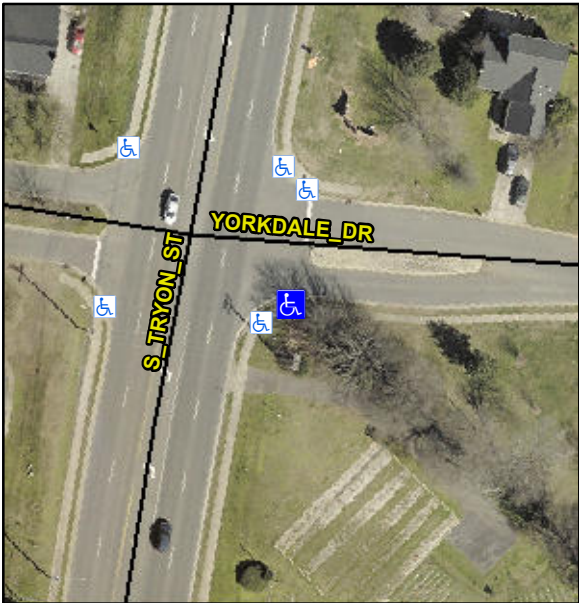
Possible Solutions:		Compliance	Description	Data	Compliance	Description	Data
	Remove & Replace Entire Ramp.		N/A	Ramp Length (in)	96.0	No	Ramp Slope (%)	9.6
			Yes	Ramp Width (in)	48.0	No	Ramp XSlope (%)	3.7
			N/A	Flare Type LT	N/A	N/A	Flare Type RT	N/A
			N/A	Flare Slope LT (%)	N/A	N/A	Flare Slope RT (%)	N/A
			N/A	Flare Traversable LT?	N/A	N/A	Flare Traversable RT?	N/A
			N/A	Landing Length (in)	N/A	N/A	DWS Provided?	N/A
			N/A	Landing Width (in)	N/A	N/A	DWS Contrast?	N/A
			N/A	Landing Slope (%)	N/A	N/A	DWS Length (in)	N/A
			N/A	Landing X Slope (%)	N/A	N/A	DWS Full Width?	N/A
Surveyor Notes:	N/A		N/A	Landing Curb? (Y/N)	N/A	N/A	DWS Offset (in)	N/A
			N/A	Shared Landing?	N/A			
			N/A	Gutter Ponding?	N/A	N/A	Gutter Slope (%)	N/A
			N/A	Gutter Lip Ht (in)	N/A	N/A	Gutter X Slope (%)	N/A
			N/A	Painted X Walk1?	No	N/A	Painted X Walk2?	N/A

X Walk 1 Direction	To N		X Walk 2 Direction	N/A
			N/A	X Walk 1 Width (in)	N/A	N/A	X Walk 2 Width (in)	N/A
				X Walk 1 Slope (%)	1.3		X Walk 2 Slope (%)	N/A
				X Walk 1 X Slope (%)	4.7		X Walk 2 X Slope (%)	N/A
			N/A	Ramp inside XWalk1?	N/A	N/A	Ramp inside XWalk2?	N/A
PROW/ADA:	R304.2.2, R304.5.3			Road Slope (%)	N/A	N/A	Clear Space?	N/A
				Road X Slope (%)	N/A	N/A	Clear Space to XWalk (in)	N/A
			N/A	Any Obstructions?	N/A	N/A	Storm Grate/Utility Hazard?	N/A
				Obstruction Type			Storm Grate/Utility Type	
					N/A			N/A
						Yes	Surface Condition? (G/P)	Good
	Total Cost:		\$	1850.00
