Access Compliance Report

Public Rights-of-Way

(Curb Ramps)

Intersection ID: 10040755	Main Street: W_TREMONT_AV	Cross Street: N/A	Location: NW
ADA ID: 27DF65314F15	Ramp Type: PerpDiag	Initial Pass/Fail: Pass	Overall Compliance: No
		Severity Score: 0

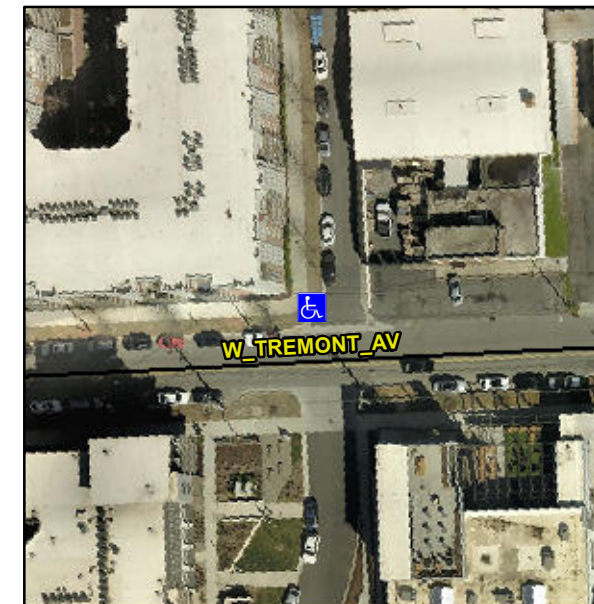
Compliance	Description	Data	Compliance	Description	Data
N/A	Ramp Length (in)	89.0	Yes	Ramp Slope (%)	5.8
Yes	Ramp Width (in)	48.0	Yes	Ramp XSlope (%)	1.2
N/A	Flare Type LT	Sloped	N/A	Flare Type RT	N/A
N/A	Flare Slope LT (%)	7.5	Yes	Flare Slope RT (%)	1.1
N/A	Flare Traversable LT?	Yes	N/A	Flare Traversable RT?	Yes
Yes	Landing Length (in)	96.0	Yes	DWS Provided?	Yes
Yes	Landing Width (in)	48.0	Yes	DWS Contrast?	Yes
Yes	Landing Slope (%)	1.3	Yes	DWS Length (in)	24.0
No	Landing X Slope (%)	2.7	Yes	DWS Full Width?	Yes
N/A	Landing Curb? (Y/N)	No	Yes	DWS Offset (in)	2.0
N/A	Shared Landing?	No			
Yes	Gutter Ponding?	No	Yes	Gutter Slope (%)	0.8
Yes	Gutter Lip Ht (in)	0.0	Yes	Gutter X Slope (%)	1.7
N/A	Painted X Walk1?	No	N/A	Painted X Walk2?	No
	X Walk 1 Direction	To E		X Walk 2 Direction	To SW
N/A	X Walk 1 Width (in)	N/A	N/A	X Walk 2 Width (in)	N/A
	X Walk 1 Slope (%)	5.7		X Walk 2 Slope (%)	5.9
	X Walk 1 X Slope (%)	3.8		X Walk 2 X Slope (%)	1.1

N/A	Ramp inside XWalk1?	N/A	N/A	Ramp inside XWalk2?	N/A
	Road Slope (%)	1.9	N/A	Clear Space?	Yes
	Road X Slope (%)	3.9	N/A	Clear Space to XWalk (in)	N/A
Yes	Any Obstructions?	No	Yes	Storm Grate/Utility Hazard?	No
	Obstruction Type			Storm Grate/Utility Type	
			N/A		N/A
			Yes	Surface Condition? (G/P)	Good

Possible Solutions:

Remove & Replace Landing.

PROW/ADA:

R304.5.3

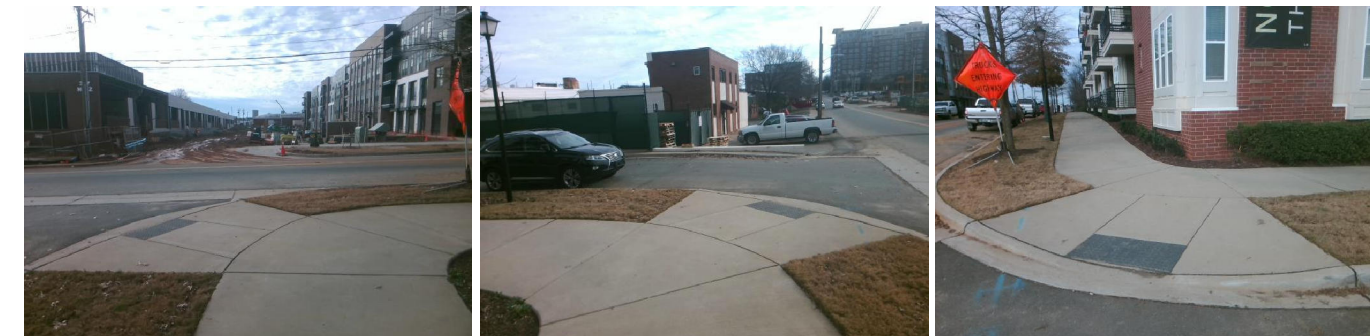
Street 1 Name	ENTRANCE
Stop Condition-Street 2	None
Street 2 Name	W TREMONT AV
Stop Condition-Street 1	None
