# Access Compliance Report

## Public Rights-of-Way

### (Curb Ramps)

| ADA ID: 27ED902A3156 | Ramp Type: BlendTrans1 | Initial Pass/Fail: Pass | Overall Compliance: No |

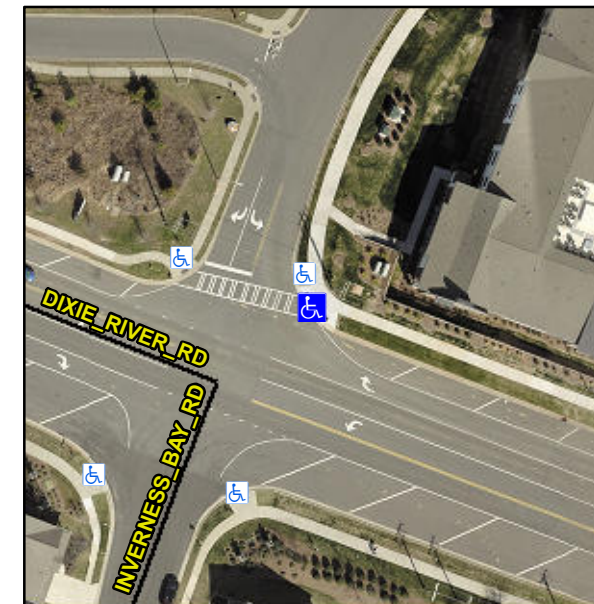
| Compliance | Description | Data | Compliance | Description | Data |
|---|---|---|---|---|---|
| N/A | Landing Curb? (Y/N) | No | No | DWS Offset (in) | 4.5 |
| Yes | Gutter Lip Ht (in) | 0.0 | No | Gutter X Slope (%) | 2.2 |

**Remove & Replace Detectable Warning System. Remove & Replace Gutter.**

**R305.2, R304.5.3**

Total Cost: \$ 1550.00
