Access Compliance Report Public Rights-of-Way (Curb Ramps)

Intersection ID: 26451 Main Street: PARK RD **Cross Street: KINGFISHER DR** Location: NW **Overall Compliance: No ADA ID: 27EF154FDDAA** Ramp Type: PerpDiag Initial Pass/Fail: Fail Severity Score: 21.25

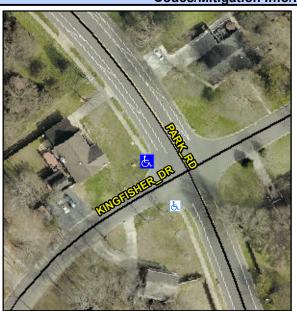
Street 1 Name KINGFISHER DR Stop Condition-Street 2 StopSign **PARK RD** Street 2 Name Stop Condition-Street 1 None Possible Solutions: Remove & Replace Curb Ramp With Two New Directional Ramps or Equivalent. Surveyor Notes: N/A PROW/ADA: Not Found, R304.5.1, R304.2.2
