# Access Compliance Report

## Public Rights-of-Way

### (Curb Ramps)

Intersection ID: 31672	Main Street: EAVES_LN	Cross Street: PLAZA_WALK_DR	Location: NE
ADA ID: 27F21BA4B253	Ramp Type: BlendTrans1	Initial Pass/Fail: Fail	Overall Compliance: No
Severity Score: 8.75			
Codes/Mitigation Info/Possible Solution		Field Measurements/Component Compliance

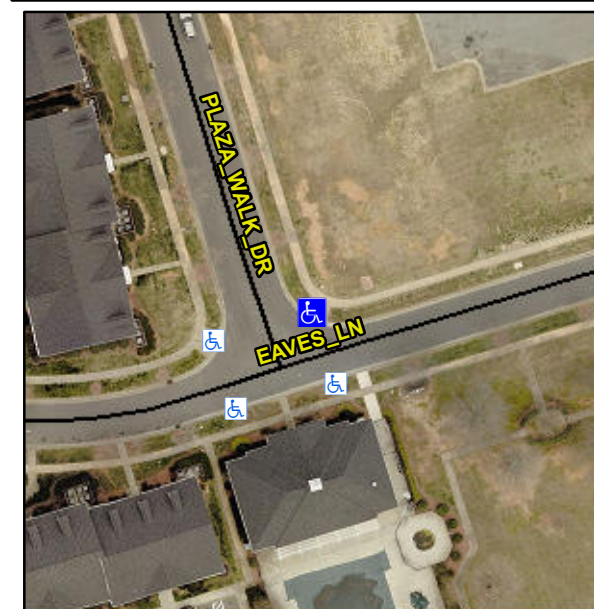
Compliance	Description	Data	Compliance	Description	Data
N/A	Ramp Length (in)	100.0	Yes	BlendTrans Slope (%)	4.2
No	Ramp Width (in)	44.0	Yes	BlendTrans XSlope (%)	1.0
N/A	Flare Type LT	N/A	N/A	Flare Type RT	N/A
N/A	Flare Slope LT (%)	N/A	N/A	Flare Slope RT (%)	N/A
N/A	Flare Traversable LT?	N/A	N/A	Flare Traversable RT?	N/A
N/A	Landing Length (in)	N/A	N/A	DWS Provided?	N/A
N/A	Landing Width (in)	N/A	N/A	DWS Contrast?	N/A
N/A	Landing Slope (%)	N/A	N/A	DWS Length (in)	N/A
N/A	Landing X Slope (%)	N/A	N/A	DWS Full Width?	N/A
N/A	Landing Curb? (Y/N)	N/A	N/A	DWS Offset (in)	N/A
N/A	Shared Landing?	N/A			
N/A	Gutter Ponding?	N/A	N/A	Gutter Slope (%)	N/A
N/A	Gutter Lip Ht (in)	N/A	N/A	Gutter X Slope (%)	N/A
N/A	Painted X Walk1?	No	N/A	Painted X Walk2?	No
	X Walk 1 Direction	To SW		X Walk 2 Direction	To SE
	X Walk 1 Width (in)	N/A		X Walk 2 Width (in)	N/A
	X Walk 1 Slope (%)	2.3		X Walk 2 Slope (%)	0.6
	X Walk 1 X Slope (%)	2.3		X Walk 2 X Slope (%)	2.0

N/A	Ramp inside XWalk1?	N/A	N/A	Ramp inside XWalk2?	N/A
	Road Slope (%)	0.1		Clear Space?	N/A
	Road X Slope (%)	4.4	N/A	Clear Space to XWalk (in)	N/A
N/A	Any Obstructions?	N/A	N/A	Storm Grate/Utility Hazard?	N/A
	Obstruction Type			Storm Grate/Utility Type	
		N/A			N/A
			Yes	Surface Condition? (G/P)	Good
			N/A	Curb Slope (%)	4.9

**Remove & Replace Curb Ramp With Two New Directional Ramps or Equivalent.**

**R304.5.1**
