Access Compliance Report

Public Rights-of-Way (Curb Ramps)

Intersection ID: 50610	Main Street: GOLDEN_WOOD_LN	Cross Street: DOWNY_BIRCH_RD	Location: NE
ADA ID: 27F30BA8DD8E	Ramp Type: Perp	Initial Pass/Fail: Fail	Overall Compliance: No Severity Score: 13.75

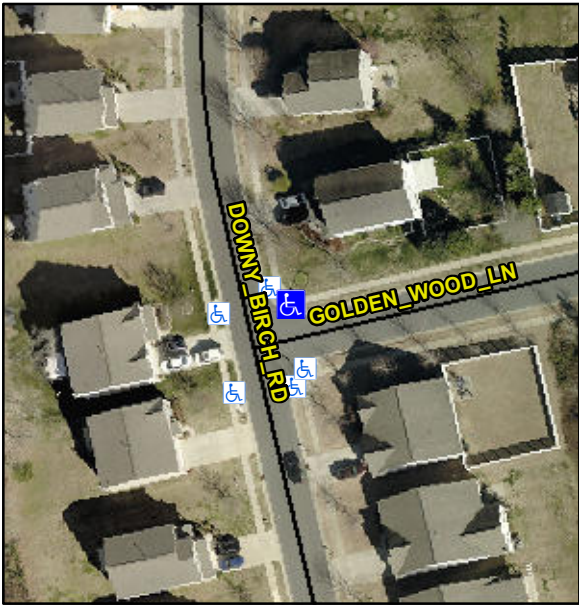
Possible Solutions:			Compliance	Description	Data	Compliance	Description	Data
	Remove & Replace Entire Ramp.			N/A	Ramp Length (in)	47.5	No	Ramp Slope (%)	9.0
				Yes	Ramp Width (in)	48.0	No	Ramp XSlope (%)	2.8
				N/A	Flare Type LT	N/A	N/A	Flare Type RT	N/A
				N/A	Flare Slope LT (%)	N/A	N/A	Flare Slope RT (%)	N/A
				N/A	Flare Traversable LT?	N/A	N/A	Flare Traversable RT?	N/A
				N/A	Landing Length (in)	N/A	N/A	DWS Provided?	N/A
				N/A	Landing Width (in)	N/A	N/A	DWS Contrast?	N/A
				N/A	Landing Slope (%)	N/A	N/A	DWS Length (in)	N/A
				N/A	Landing X Slope (%)	N/A	N/A	DWS Full Width?	N/A
Surveyor Notes:			N/A	Landing Curb? (Y/N)	N/A	N/A	DWS Offset (in)	N/A	N/A
PROW/ADA:			N/A	Shared Landing?	N/A				
Not Found, R304.2.2, R304.5.3			N/A	Gutter Ponding?	N/A	N/A	N/A	Gutter Slope (%)	N/A
			N/A	Gutter Lip Ht (in)	N/A	N/A	N/A	Gutter X Slope (%)	N/A

N/A	Painted X Walk1?	No	N/A	N/A	Painted X Walk2?	N/A
				X Walk 1 Direction	To S			X Walk 2 Direction	N/A
			N/A	X Walk 1 Width (in)	N/A	N/A	N/A	X Walk 2 Width (in)	N/A
				X Walk 1 Slope (%)	5.5			X Walk 2 Slope (%)	N/A
				X Walk 1 X Slope (%)	2.1			X Walk 2 X Slope (%)	N/A
			N/A	Ramp inside XWalk1?	N/A	N/A	N/A	Ramp inside XWalk2?	N/A
				Road Slope (%)	N/A	N/A	N/A	Clear Space?	N/A
				Road X Slope (%)	N/A	N/A	N/A	Clear Space to XWalk (in)	N/A
			N/A	Any Obstructions?	N/A	N/A	N/A	Storm Grate/Utility Hazard?	N/A
				Obstruction Type				Storm Grate/Utility Type	
						N/A			N/A
							Yes	Surface Condition? (G/P)	Good
Total Cost:			\$	1850.00
