Access Compliance Report Public Rights-of-Way (Curb Ramps)

Intersection ID: 45520 Main Street: COTTON_PRESS_RD Cross Street: ARDREY_WOODS_DR Location: N

ADA ID: 27F3C8A3E437 Ramp Type: Perp Initial Pass/Fail: Fail Overall Compliance: No Severity Score: 10

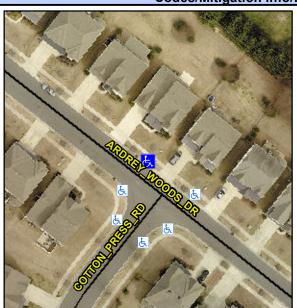
Not Found, R304.5.1, R304.5.3

| Field Measurements/Component Compliance | | | | | |
|---|---|---|---|---|---|
| N/A | Ramp Length (in) | 70.0 | Yes | Ramp Slope (%) | 8.0 |
| No | Ramp Width (in) | 36.0 | No | Ramp XSlope (%) | 4.1 |

Remove & Replace Entire Ramp.

Total Cost: \$ 1850.00
