# Access Compliance Report

## Public Rights-of-Way

### (Curb Ramps)

Intersection ID: 28846	Main Street: BRENLY_CT	Cross Street: FAIRCHASE_AV	Location: NW
ADA ID: 27F69A57810D	Ramp Type: PerpDiag	Initial Pass/Fail: Pass	Overall Compliance: No
		Severity Score: 17.5

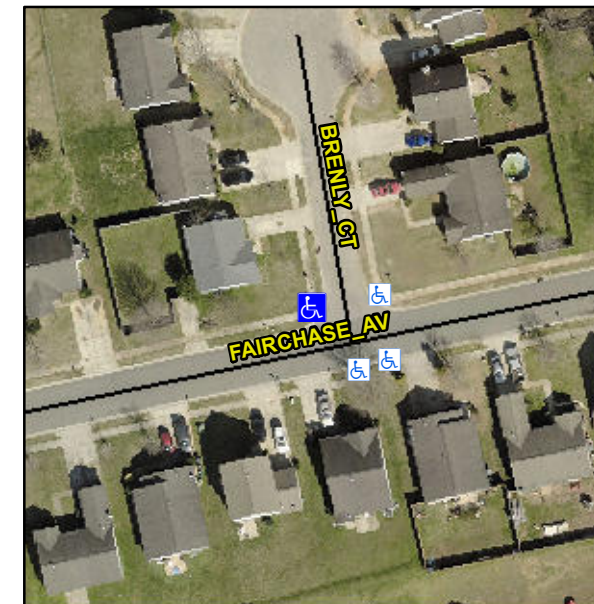
Compliance	Description	Data	Compliance	Description	Data
N/A	Ramp Length (in)	99.0	Yes	Ramp Slope (%)	6.7
Yes	Ramp Width (in)	50.0	Yes	Ramp XSlope (%)	1.0
N/A	Flare Type LT	Sloped	N/A	Flare Type RT	N/A
N/A	Flare Slope LT (%)	4.6	N/A	Flare Slope RT (%)	6.3
N/A	Flare Traversable LT?	No	N/A	Flare Traversable RT?	No
Yes	Landing Length (in)	48.0	No	DWS Provided?	No
Yes	Landing Width (in)	68.0	N/A	DWS Contrast?	No
Yes	Landing Slope (%)	1.7	N/A	DWS Length (in)	N/A
Yes	Landing X Slope (%)	2.0	N/A	DWS Full Width?	No
N/A	Landing Curb? (Y/N)	No	N/A	DWS Offset (in)	N/A
N/A	Shared Landing?	No			
Yes	Gutter Ponding?	No	Yes	Gutter Slope (%)	4.1
No	Gutter Lip Ht (in)	0.5	Yes	Gutter X Slope (%)	0.7
N/A	Painted X Walk1?	No	N/A	Painted X Walk2?	No
	X Walk 1 Direction	To S		X Walk 2 Direction	To E
N/A	X Walk 1 Width (in)	N/A	N/A	X Walk 2 Width (in)	N/A
	X Walk 1 Slope (%)	4.1		X Walk 2 Slope (%)	4.2
	X Walk 1 X Slope (%)	3.5		X Walk 2 X Slope (%)	2.1

N/A	Ramp inside XWalk1?	N/A	N/A	Ramp inside XWalk2?	N/A
	Road Slope (%)	0.4	N/A	Clear Space?	Yes
	Road X Slope (%)	6.7	N/A	Clear Space to XWalk (in)	N/A
Yes	Any Obstructions?	No	Yes	Storm Grate/Utility Hazard?	No
	Obstruction Type			Storm Grate/Utility Type	
		N/A			N/A
			Yes	Surface Condition? (G/P)	Good

**Remove & Replace Curb Ramp With Two New Directional Ramps or Equivalent.**

**Not Found, R305, R302.7.2**

Total Cost: \$ 3200.00

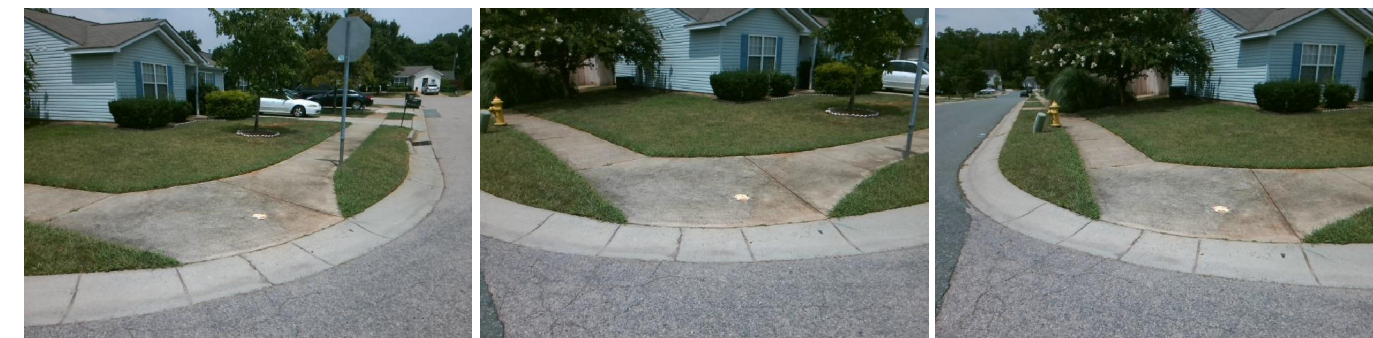
Street 1 Name FAIRCHASE AV  
 Stop Condition-Street 2 None  
 Street 2 Name BRENLY CT  
 Stop Condition-Street 1 StopSign
