# Access Compliance Report

## Public Rights-of-Way

### (Curb Ramps)

Intersection ID: 51059	Main Street: CORY-BRET_LN	Cross Street: CRAIGMOSS_LN	Location: NE
ADA ID: 28015C80B471	Ramp Type: PerpDiag	Initial Pass/Fail: Fail	Overall Compliance: No
		Severity Score: 12.5

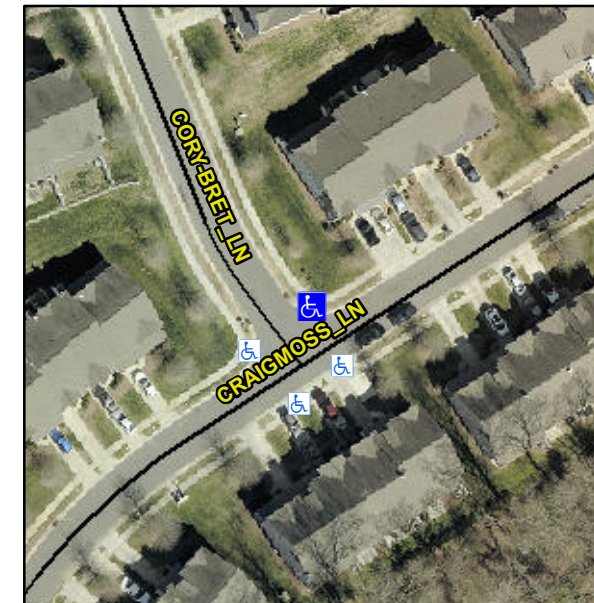
**Not Found, R304.2.2**

Compliance	Description	Data	Compliance	Description	Data
N/A	Ramp Length (in)	48.0	No	Ramp Slope (%)	8.6
Yes	Ramp Width (in)	48.0	Yes	Ramp XSlope (%)	2.0
N/A	Flare Type LT	N/A	N/A	Flare Type RT	N/A
N/A	Flare Slope LT (%)	N/A	N/A	Flare Slope RT (%)	N/A
N/A	Flare Traversable LT?	N/A	N/A	Flare Traversable RT?	N/A
N/A	Landing Length (in)	N/A	N/A	DWS Provided?	N/A
N/A	Landing Width (in)	N/A	N/A	DWS Contrast?	N/A
N/A	Landing Slope (%)	N/A	N/A	DWS Length (in)	N/A
N/A	Landing X Slope (%)	N/A	N/A	DWS Full Width?	N/A
N/A	Landing Curb? (Y/N)	N/A	N/A	DWS Offset (in)	N/A
N/A	Shared Landing?	N/A			
N/A	Gutter Ponding?	N/A	N/A	Gutter Slope (%)	N/A
N/A	Gutter Lip Ht (in)	N/A	N/A	Gutter X Slope (%)	N/A
N/A	Painted X Walk1?	No	N/A	Painted X Walk2?	No
	X Walk 1 Direction	To SW		X Walk 2 Direction	To SE
N/A	X Walk 1 Width (in)	N/A	N/A	X Walk 2 Width (in)	N/A
	X Walk 1 Slope (%)	0.3		X Walk 2 Slope (%)	0.5
	X Walk 1 X Slope (%)	0.7		X Walk 2 X Slope (%)	0.7

N/A	Ramp inside XWalk1?	N/A	N/A	Ramp inside XWalk2?	N/A
	Road Slope (%)	0.5	N/A	Clear Space?	N/A
	Road X Slope (%)	4.3	N/A	Clear Space to XWalk (in)	N/A
N/A	Any Obstructions?	N/A	N/A	Storm Grate/Utility Hazard?	N/A
	Obstruction Type			Storm Grate/Utility Type	
		N/A			N/A
		Yes		Surface Condition? (G/P)	Good

**Remove & Replace Curb Ramp With Two New Directional Ramps or Equivalent.**

Total Cost: \$ 3200.00
