Intersection ID: 9372	Main Street: N_SMALLWOOD_PL	Cross Street: SELDON_DR	Location:	N
ADA ID: 28041D107FDB	Ramp Type: BlendTrans1	Initial Pass/Fail: Fail	Overall Compliance: No	Severity Score: 12.5

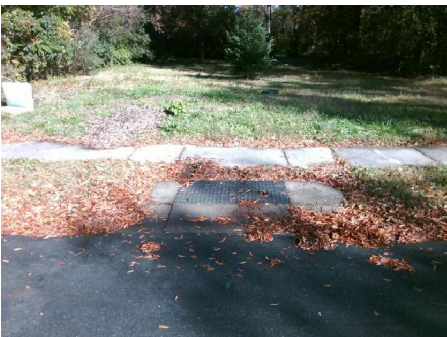
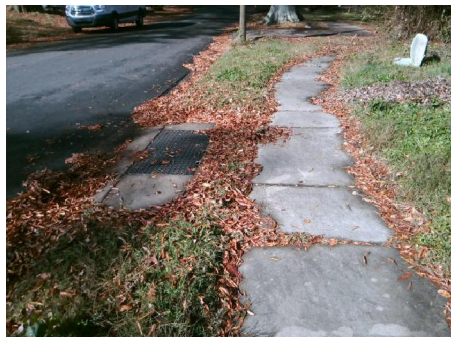
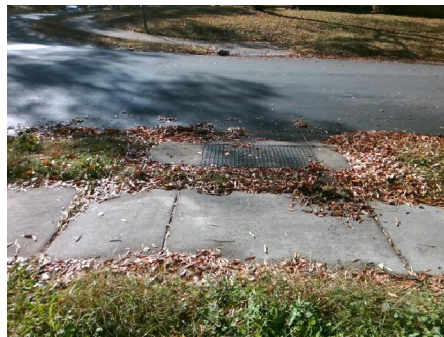
## VEGETATION OVERGROWTH

**Not Found, R304.5.3**

Compliance	Description	Data	Compliance	Description	Data
N/A	Ramp Length (in)	37.0	Yes	BlendTrans Slope (%)	2.3
Yes	Ramp Width (in)	48.0	No	BlendTrans XSlope (%)	5.8
N/A	Flare Type LT	N/A	N/A	Flare Type RT	N/A
N/A	Flare Slope LT (%)	N/A	N/A	Flare Slope RT (%)	N/A
N/A	Flare Traversable LT?	N/A	N/A	Flare Traversable RT?	N/A
N/A	Landing Length (in)	N/A	N/A	DWS Provided?	N/A
N/A	Landing Width (in)	N/A	N/A	DWS Contrast?	N/A
N/A	Landing Slope (%)	N/A	N/A	DWS Length (in)	N/A
N/A	Landing X Slope (%)	N/A	N/A	DWS Full Width?	N/A
N/A	Landing Curb? (Y/N)	N/A	N/A	DWS Offset (in)	N/A
N/A	Shared Landing?	N/A			
N/A	Gutter Ponding?	N/A	N/A	Gutter Slope (%)	N/A
N/A	Gutter Lip Ht (in)	N/A	N/A	Gutter X Slope (%)	N/A
N/A	Painted X Walk1?	No	N/A	Painted X Walk2?	N/A
	X Walk 1 Direction	To S		X Walk 2 Direction	N/A
	X Walk 1 Width (in)	N/A		X Walk 2 Width (in)	N/A
	X Walk 1 Slope (%)	4.7		X Walk 2 Slope (%)	N/A
	X Walk 1 X Slope (%)	4.9		X Walk 2 X Slope (%)	N/A

N/A	Ramp inside XWalk1?	N/A	N/A	Ramp inside XWalk2?	N/A
	Road Slope (%)	4.9		Clear Space?	N/A
	Road X Slope (%)	4.7	N/A	Clear Space to XWalk (in)	N/A
N/A	Any Obstructions?	N/A	N/A	Storm Grate/Utility Hazard?	N/A
	Obstruction Type			Storm Grate/Utility Type	
		N/A			N/A
			Yes	Surface Condition? (G/P)	Good
			No	Curb Slope (%)	8.8

**Remove & Replace Curb Ramp With Two New Directional Ramps or Equivalent.**
