Access Compliance Report

Public Rights-of-Way

(Curb Ramps)

Intersection ID: 52613	Main Street: GRAHAM RIDGE DR	Cross Street: HERITAGE POND DR	Location:	E
ADA ID: 2828AB278A2C	Ramp Type: Perp	Initial Pass/Fail: Fail	Overall Compliance: No	Severity Score: 12.5
Codes/Mitigation Info/Possible Solution		Field Measurements/Component Compliance

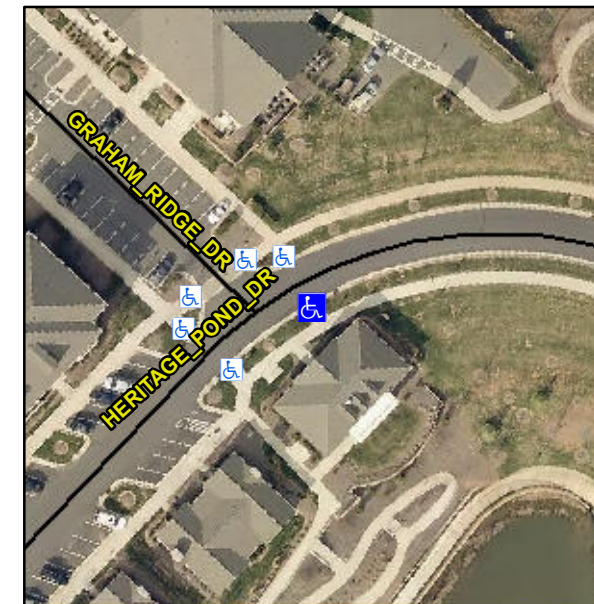
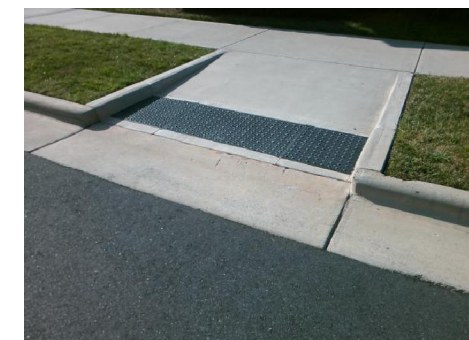
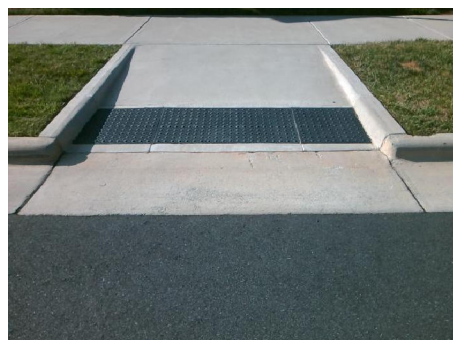
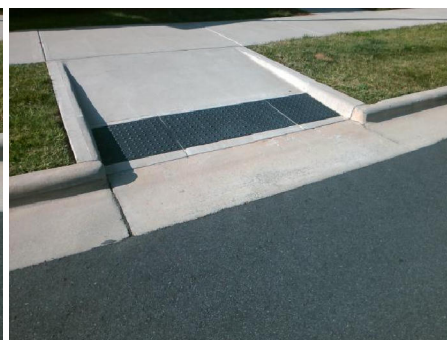
Compliance	Description	Data	Compliance	Description	Data
N/A	Ramp Length (in)	97.0	No	Ramp Slope (%)	8.8
Yes	Ramp Width (in)	94.5	Yes	Ramp XSlope (%)	1.2
N/A	Flare Type LT	N/A	N/A	Flare Type RT	N/A
N/A	Flare Slope LT (%)	N/A	N/A	Flare Slope RT (%)	N/A
N/A	Flare Traversable LT?	N/A	N/A	Flare Traversable RT?	N/A
N/A	Landing Length (in)	N/A	N/A	DWS Provided?	N/A
N/A	Landing Width (in)	N/A	N/A	DWS Contrast?	N/A
N/A	Landing Slope (%)	N/A	N/A	DWS Length (in)	N/A
N/A	Landing X Slope (%)	N/A	N/A	DWS Full Width?	N/A
N/A	Landing Curb? (Y/N)	N/A	N/A	DWS Offset (in)	N/A
N/A	Shared Landing?	N/A			
N/A	Gutter Ponding?	N/A	N/A	Gutter Slope (%)	N/A
N/A	Gutter Lip Ht (in)	N/A	N/A	Gutter X Slope (%)	N/A
N/A	Painted X Walk1?	No	N/A	Painted X Walk2?	N/A
	X Walk 1 Direction	To NW		X Walk 2 Direction	N/A
N/A	X Walk 1 Width (in)	N/A	N/A	X Walk 2 Width (in)	N/A
	X Walk 1 Slope (%)	5.1		X Walk 2 Slope (%)	N/A
	X Walk 1 X Slope (%)	0.7		X Walk 2 X Slope (%)	N/A

N/A	Ramp inside XWalk1?	N/A	N/A	Ramp inside XWalk2?	N/A
	Road Slope (%)	N/A	N/A	Clear Space?	N/A
	Road X Slope (%)	N/A	N/A	Clear Space to XWalk (in)	N/A
N/A	Any Obstructions?	N/A	N/A	Storm Grate/Utility Hazard?	N/A
	Obstruction Type			Storm Grate/Utility Type	
		N/A			N/A
			Yes	Surface Condition? (G/P)	Good

Possible Solutions:

Remove & Replace Entire Ramp.

R304.2.2

\$ 1850.00
