# Access Compliance Report

## Public Rights-of-Way

### (Curb Ramps)

Intersection ID: 8637	Main Street: STATESVILLE_AV	Cross Street: SAMUEL_ST	Location: NW
ADA ID: 2829ED3BCDA4	Ramp Type: Perp	Initial Pass/Fail: Fail	Overall Compliance: No
Severity Score: 8.75			
Codes/Mitigation Info/Possible Solution		Field Measurements/Component Compliance

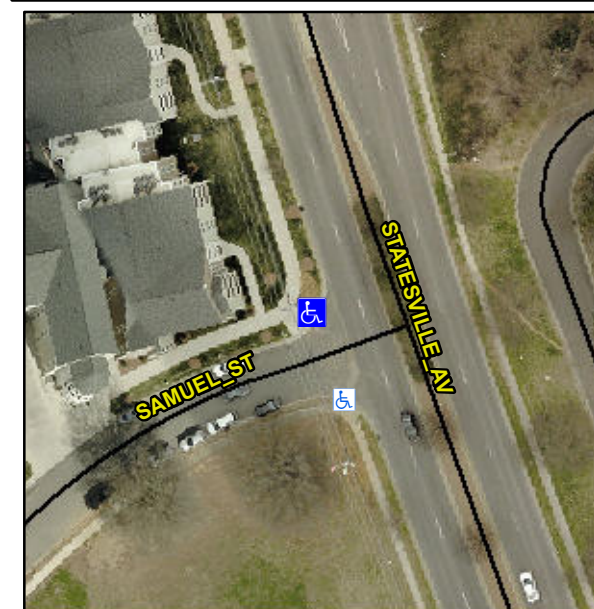
Compliance	Description	Data	Compliance	Description	Data
N/A	Ramp Length (in)	120.0	Yes	Ramp Slope (%)	5.4
No	Ramp Width (in)	47.0	Yes	Ramp XSlope (%)	1.5
N/A	Flare Type LT	N/A	N/A	Flare Type RT	N/A
N/A	Flare Slope LT (%)	N/A	N/A	Flare Slope RT (%)	N/A
N/A	Flare Traversable LT?	N/A	N/A	Flare Traversable RT?	N/A
N/A	Landing Length (in)	N/A	N/A	DWS Provided?	N/A
N/A	Landing Width (in)	N/A	N/A	DWS Contrast?	N/A
N/A	Landing Slope (%)	N/A	N/A	DWS Length (in)	N/A
N/A	Landing X Slope (%)	N/A	N/A	DWS Full Width?	N/A
N/A	Landing Curb? (Y/N)	N/A	N/A	DWS Offset (in)	N/A
N/A	Shared Landing?	N/A			
N/A	Gutter Ponding?	N/A	N/A	Gutter Slope (%)	N/A
N/A	Gutter Lip Ht (in)	N/A	N/A	Gutter X Slope (%)	N/A
N/A	Painted X Walk1?	No	N/A	Painted X Walk2?	N/A
	X Walk 1 Direction	To S		X Walk 2 Direction	N/A
N/A	X Walk 1 Width (in)	N/A	N/A	X Walk 2 Width (in)	N/A
	X Walk 1 Slope (%)	5.0		X Walk 2 Slope (%)	N/A
	X Walk 1 X Slope (%)	3.5		X Walk 2 X Slope (%)	N/A

N/A	Ramp inside XWalk1?	N/A	N/A	Ramp inside XWalk2?	N/A
	Road Slope (%)	N/A	N/A	Clear Space?	N/A
	Road X Slope (%)	N/A	N/A	Clear Space to XWalk (in)	N/A
N/A	Any Obstructions?	N/A	N/A	Storm Grate/Utility Hazard?	N/A
	Obstruction Type			Storm Grate/Utility Type	
		N/A			N/A
			Yes	Surface Condition? (G/P)	Good

Possible Solutions:

**Remove & Replace Entire Ramp.**

**R304.5.1**

Total Cost: \$ 1850.00
