Access Compliance Report

Public Rights-of-Way

(Curb Ramps)

Intersection ID: 52926	Main Street: WALTHAM_LN	Cross Street: EMORY_OAK_DR	Location: E
ADA ID: 282DC42B35B2	Ramp Type: Perp	Initial Pass/Fail: Fail	Overall Compliance: No
Severity Score: 8.75			
Codes/Mitigation Info/Possible Solution		Field Measurements/Component Compliance

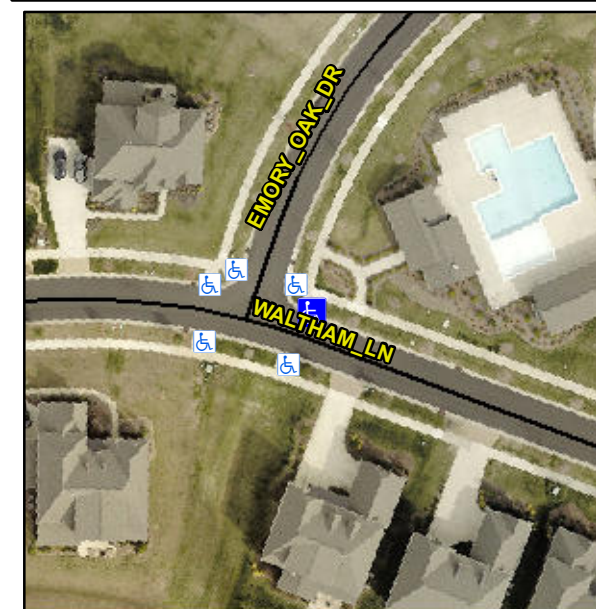
Not Found, R304.5.1

Compliance	Description	Data	Compliance	Description	Data
N/A	Ramp Length (in)	95.5	Yes	Ramp Slope (%)	5.0
No	Ramp Width (in)	44.5	Yes	Ramp XSlope (%)	1.0
N/A	Flare Type LT	N/A	N/A	Flare Type RT	N/A
N/A	Flare Slope LT (%)	N/A	N/A	Flare Slope RT (%)	N/A
N/A	Flare Traversable LT?	N/A	N/A	Flare Traversable RT?	N/A
N/A	Landing Length (in)	N/A	N/A	DWS Provided?	N/A
N/A	Landing Width (in)	N/A	N/A	DWS Contrast?	N/A
N/A	Landing Slope (%)	N/A	N/A	DWS Length (in)	N/A
N/A	Landing X Slope (%)	N/A	N/A	DWS Full Width?	N/A
N/A	Landing Curb? (Y/N)	N/A	N/A	DWS Offset (in)	N/A
N/A	Shared Landing?	N/A			
N/A	Gutter Ponding?	N/A	N/A	Gutter Slope (%)	N/A
N/A	Gutter Lip Ht (in)	N/A	N/A	Gutter X Slope (%)	N/A
N/A	Painted X Walk1?	No	N/A	Painted X Walk2?	N/A
	X Walk 1 Direction	To S		X Walk 2 Direction	N/A
N/A	X Walk 1 Width (in)	N/A	N/A	X Walk 2 Width (in)	N/A
	X Walk 1 Slope (%)	2.9		X Walk 2 Slope (%)	N/A
	X Walk 1 X Slope (%)	1.1		X Walk 2 X Slope (%)	N/A

N/A	Ramp inside XWalk1?	N/A	N/A	Ramp inside XWalk2?	N/A
	Road Slope (%)	N/A	N/A	Clear Space?	N/A
	Road X Slope (%)	N/A	N/A	Clear Space to XWalk (in)	N/A
N/A	Any Obstructions?	N/A	N/A	Storm Grate/Utility Hazard?	N/A
	Obstruction Type			Storm Grate/Utility Type	
		N/A			N/A
		Yes		Surface Condition? (G/P)	Good

Remove & Replace Entire Ramp.
