Access Compliance Report

Public Rights-of-Way

(Curb Ramps)

Intersection ID: 46193	Main Street: GALARDIA_RD	Cross Street: SEVEN_OAKS_DR	Location: SE
ADA ID: 2831849996F0	Ramp Type: PerpDiag	Initial Pass/Fail: Fail	Overall Compliance: No
Severity Score: 10			
Codes/Mitigation Info/Possible Solution		Field Measurements/Component Compliance

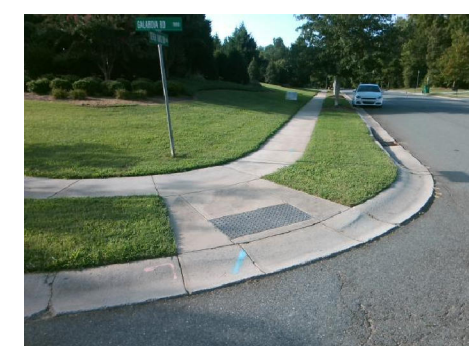
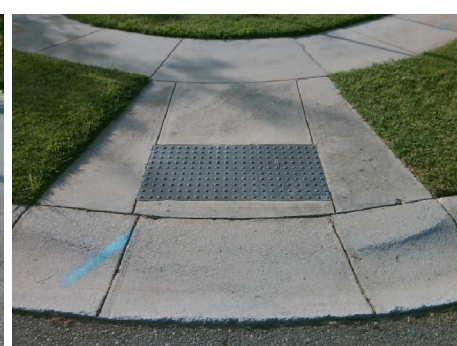
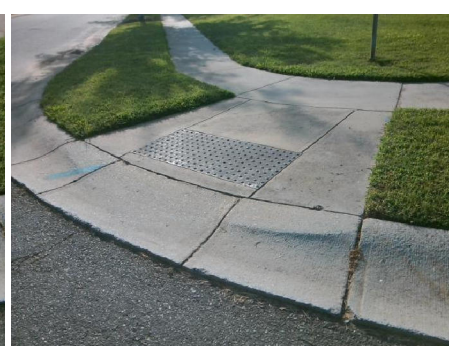
N/A	Shared Landing?	N/A			
		N/A	Gutter Ponding?	N/A	N/A	Gutter Slope (%)	N/A
		N/A	Gutter Lip Ht (in)	1.0	N/A	Gutter X Slope (%)	N/A
		N/A	Painted X Walk1?	No	N/A	Painted X Walk2?	No
			X Walk 1 Direction	To N		X Walk 2 Direction	To W
		N/A	X Walk 1 Width (in)	N/A	N/A	X Walk 2 Width (in)	N/A
			X Walk 1 Slope (%)	3.2		X Walk 2 Slope (%)	1.6
			X Walk 1 X Slope (%)	1.2		X Walk 2 X Slope (%)	2.9
		N/A	Ramp inside XWalk1?	N/A	N/A	Ramp inside XWalk2?	N/A
			Road Slope (%)	3.1	N/A	Clear Space?	N/A
			Road X Slope (%)	1.4	N/A	Clear Space to XWalk (in)	N/A
		N/A	Any Obstructions?	N/A	N/A	Storm Grate/Utility Hazard?	N/A
			Obstruction Type			Storm Grate/Utility Type	
				N/A			N/A
					Yes	Surface Condition? (G/P)	Good

<p>Possible Solutions:</p> <p>Remove & Replace Curb Ramp With Two New Directional Ramps or Equivalent.</p>	<p>Surveyor Notes:</p> <p>N/A</p>			<p>PROW/ADA:</p> <p>Not Found, R304.5.1, R304.5.3</p>		
		<p>Total Cost: \$ 3200.00</p>					
Street 1 Name	GALARDIA RD	Compliance	Description	Data	Compliance	Description	Data
Stop Condition-Street 2	StopSign	N/A	Ramp Length (in)	72.0	Yes	Ramp Slope (%)	5.1
Street 2 Name	SEVEN OAKS RD	No	Ramp Width (in)	46.5	No	Ramp XSlope (%)	4.6
Stop Condition-Street 1	None	N/A	Flare Type LT	N/A	N/A	Flare Type RT	N/A
		N/A	Flare Slope LT (%)	N/A	N/A	Flare Slope RT (%)	N/A
		N/A	Flare Traversable LT?	N/A	N/A	Flare Traversable RT?	N/A
		N/A	Landing Length (in)	N/A	N/A	DWS Provided?	N/A
		N/A	Landing Width (in)	N/A	N/A	DWS Contrast?	N/A
		N/A	Landing Slope (%)	N/A	N/A	DWS Length (in)	N/A
		N/A	Landing X Slope (%)	N/A	N/A	DWS Full Width?	N/A
		N/A	Landing Curb? (Y/N)	N/A	N/A	DWS Offset (in)	N/A
