Access Compliance Report Public Rights-of-Way (Curb Ramps)

Intersection ID: 4743 Main Street: BELLHAVEN BV Cross Street: MT HOLLY-HUNTERSVILLE RD Location: ADA ID: 2834AA6C9074 Ramp Type: BlendTrans2 Initial Pass/Fail: Fail **Overall Compliance: No Severity Score:** 8.75

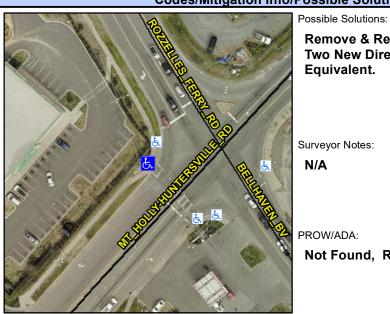
Not Found, R304.5.1

Field Measurements/Component Compliance					
Compliance Description		Data	Compliance Description		Data
N/A	Ramp Length (in)	59.0	Yes	BlendTrans Slope (%)	4.3
No	Ramp Width (in)	47.0	Yes	BlendTrans XSlope (%)	0.8
N/A	Flare Type LT	N/A	N/A	Flare Type RT	N/A
N/A	Flare Slope LT (%)	N/A	N/A	Flare Slope RT (%)	N/A
N/A	Flare Traversable LT?	N/A	N/A	Flare Traversable RT?	N/A
N/A	Landing Length (in)	N/A	N/A	DWS Provided?	N/A
N/A	Landing Width (in)	N/A	N/A	DWS Contrast?	N/A
N/A	Landing Slope (%)	N/A	N/A	DWS Length (in)	N/A
N/A	Landing X Slope (%)	N/A	N/A	DWS Full Width?	N/A
N/A	Landing Curb? (Y/N)	N/A	N/A	DWS Offset (in)	N/A
N/A	Shared Landing?	N/A			
N/A	Gutter Ponding?	N/A	N/A	Gutter Slope (%)	N/A
N/A	Gutter Lip Ht (in)	N/A	N/A	Gutter X Slope (%)	N/A
N/A	Painted X Walk1?	Yes	N/A	Painted X Walk2?	N/A
	X Walk 1 Direction	To SE		X Walk 2 Direction	N/A
	X Walk 1 Width (in)	110.5		X Walk 2 Width (in)	N/A
	X Walk 1 Slope (%)	1.1		X Walk 2 Slope (%)	N/A

X Walk 1 X Slope (%)	1.3		X Walk 2 X Slope (%)	N/A
N/A	Ramp inside XWalk1?	Yes	N/A	Ramp inside XWalk2?	N/A
	Road Slope (%)	1.3		Clear Space?	N/A
	Road X Slope (%)	1.1	N/A	Clear Space to XWalk (in)	N/A
N/A	Any Obstructions?	N/A	N/A	Storm Grate/Utility Hazard?	N/A
	Obstruction Type			Storm Grate/Utility Type	
		N/A			N/A
			Yes	Surface Condition? (G/P)	Good
			No	Curb Slope (%)	7.4

MT HOLLY HUNTERSVILLE RD Street 1 Name Stop Condition-Street 1 Signal Street 2 Name N/A Stop Condition-Street 2 N/A Remove & Replace Curb Ramp With **Two New Directional Ramps or** Equivalent.

3200.00
