Access Compliance Report Public Rights-of-Way (Curb Ramps)

Intersection ID: 53236 Main Street: FLEETWOOD_DR Cross Street: DOLLY_MADISON_RD Location: SE

ADA ID: 2837621026A8 Ramp Type: Perp Initial Pass/Fail: Fail Overall Compliance: No Severity Score: 12.5

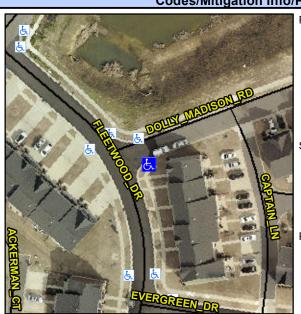
| Possible Solutions: | | | Compliance Description Da | | Data | Compl | iance | Description |
|---|---|---|---|---|---|---|---|---|
| Remove & Replace Entire | Ramp |). | N/A | Ramp Length (in) | 70.5 | No | Ram | p Slope (%) |
| Not Found, R304.2.2 | | | N/A | Gutter Lip Ht (in) | N/A | N/A | Gutte | er X Slope (%) |

| Possible Solutions: | | | Compliance Description Da | | Data | Compl | iance | Description |
| Total Cost: | \$ | 1850.00 | | Obstruction Type | | | Storr | m Grate/Utility Type |
