Access Compliance Report

Public Rights-of-Way

(Curb Ramps)

Intersection ID: 49393	Main Street: ROMANA_RED_LN	Cross Street: AUBRAC_LN	Location: SE
ADA ID: 283C4372E61F	Ramp Type: Perp	Initial Pass/Fail: Pass	Overall Compliance: No
Severity Score: 0.25			
Codes/Mitigation Info/Possible Solution		Field Measurements/Component Compliance

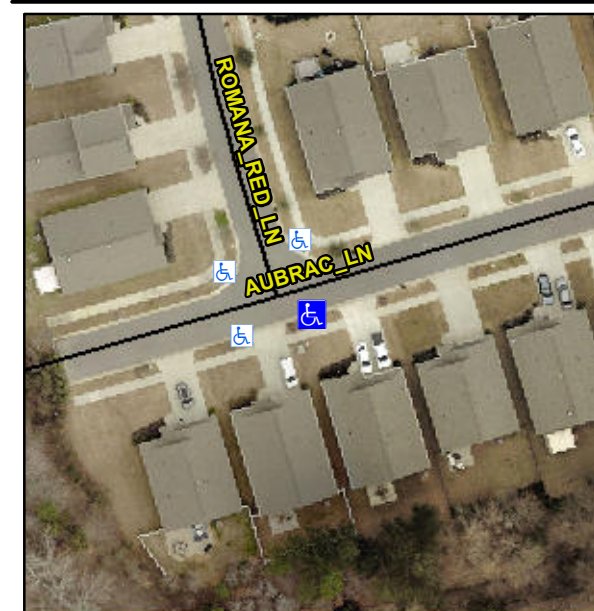
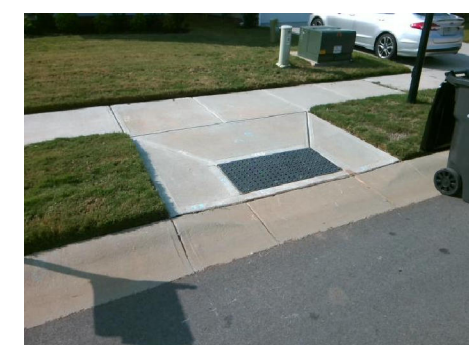
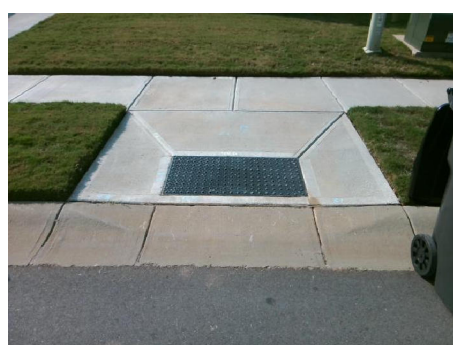
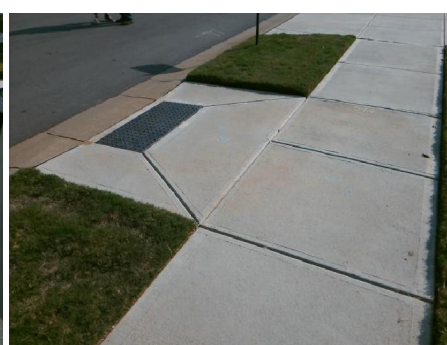
Not Found, R305.2

Compliance	Description	Data	Compliance	Description	Data
N/A	Ramp Length (in)	71.0	Yes	Ramp Slope (%)	7.0
Yes	Ramp Width (in)	48.0	Yes	Ramp XSlope (%)	2.1
N/A	Flare Type LT	Sloped	N/A	Flare Type RT	N/A
N/A	Flare Slope LT (%)	4.8	N/A	Flare Slope RT (%)	3.1
N/A	Flare Traversable LT?	No	N/A	Flare Traversable RT?	No
Yes	Landing Length (in)	59.0	Yes	DWS Provided?	Yes
Yes	Landing Width (in)	103.0	Yes	DWS Contrast?	Yes
Yes	Landing Slope (%)	0.1	Yes	DWS Length (in)	24.0
Yes	Landing X Slope (%)	1.3	Yes	DWS Full Width?	Yes
N/A	Landing Curb? (Y/N)	No	No	DWS Offset (in)	4.0
N/A	Shared Landing?	No			
Yes	Gutter Ponding?	No	Yes	Gutter Slope (%)	1.4
Yes	Gutter Lip Ht (in)	0.0	Yes	Gutter X Slope (%)	1.3
N/A	Painted X Walk1?	No	N/A	Painted X Walk2?	N/A
	X Walk 1 Direction	To N		X Walk 2 Direction	N/A
N/A	X Walk 1 Width (in)	N/A	N/A	X Walk 2 Width (in)	N/A
	X Walk 1 Slope (%)	2.8		X Walk 2 Slope (%)	N/A
	X Walk 1 X Slope (%)	4.8		X Walk 2 X Slope (%)	N/A

N/A	Ramp inside XWalk1?	N/A	N/A	Ramp inside XWalk2?	N/A
	Road Slope (%)	N/A	N/A	Clear Space?	Yes
	Road X Slope (%)	N/A	N/A	Clear Space to XWalk (in)	N/A
Yes	Any Obstructions?	No	Yes	Storm Grate/Utility Hazard?	No
	Obstruction Type			Storm Grate/Utility Type	
		N/A			N/A
			Yes	Surface Condition? (G/P)	Good

Possible Solutions:

Remove & Replace Entire Ramp.
