## Access Compliance Report Public Rights-of-Way (Curb Ramps)

Intersection ID: 20146 Main Street: FAIRVIEW\_RD Cross Street: PARK\_SOUTH\_DR Location: NE

ADA ID: 283C512AE8A2 Ramp Type: Para Initial Pass/Fail: Fail Overall Compliance: No Severity Score: 26.25

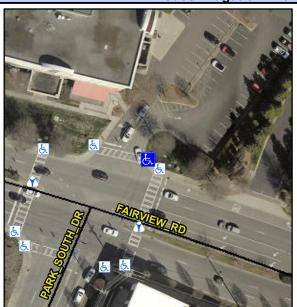
LT RP < 5%

Constitute Production Party Component Compilation Production					
Compliance Description		Data	Compliance Description		Data
N/A	Ramp Length LT (in)	56.0	N/A	Ramp Length RT (in)	53.0
Yes	Ramp Width LT (in)	72.0	Yes	Ramp Width RT (in)	72.0
Yes	Ramp Slope LT (%)	2.6	No	Ramp Slope RT (%)	14.6
Yes	Ramp XSlope LT (%)	1.6	No	Ramp XSlope RT (%)	2.9
N/A	Landing Length (in)	N/A	N/A	DWS Provided?	N/A
N/A	Landing Width (in)	N/A	N/A	DWS Contrast?	N/A
N/A	Landing Slope (%)	N/A	N/A	DWS Length (in)	N/A
N/A	Landing X Slope (%)	N/A	N/A	DWS Full Width?	N/A
N/A	Landing Curb? (Y/N)	N/A	N/A	DWS Offset (in)	N/A
N/A	Shared Landing?	N/A			
N/A	Gutter Ponding?	N/A	N/A	Gutter Slope (%)	N/A
N/A	Gutter Lip Ht (in)	N/A	N/A	Gutter X Slope (%)	N/A
N/A	Painted X Walk1?	Yes	N/A	Painted X Walk2?	N/A
	X Walk 1 Direction	To NW		X Walk 2 Direction	N/A
N/A	X Walk 1 Width (in)	81.0	N/A	X Walk 2 Width (in)	N/A
	X Walk 1 Slope (%)	2.8		X Walk 2 Slope (%)	N/A

X Walk 1 X Slope (%)	5.1		X Walk 2 X Slope (%)	N/A
N/A	Ramp inside XWalk1?	Yes	N/A	Ramp inside XWalk2?	N/A
	Road Slope (%)	N/A	N/A	Clear Space?	N/A
	Road X Slope (%)	N/A	N/A	Clear Space to XWalk (in)	N/A
N/A	Any Obstructions?	N/A	N/A	Storm Grate/Utility Hazard?	N/A
	Obstruction Type			Storm Grate/Utility Type	
	••	N/A		, ,,	N/A
			Yes	Surface Condition? (G/P)	Good
			N/A	Curb Slope (%)	7.8

Remove & Replace Entire Ramp.

R304.3.2, R304.5.3

Total Cost: \$ 1600.00
