Access Compliance Report

Public Rights-of-Way

Intersection ID: 5897	Main Street: FOREST_POND_DR	Cross Street: PINK_DOGWOOD_LN	Location: S
ADA ID: 284277A46A56	Ramp Type: BlendTrans1	Initial Pass/Fail: Fail	Overall Compliance: No
Severity Score: 10			
Codes/Mitigation Info/Possible Solution		Field Measurements/Component Compliance

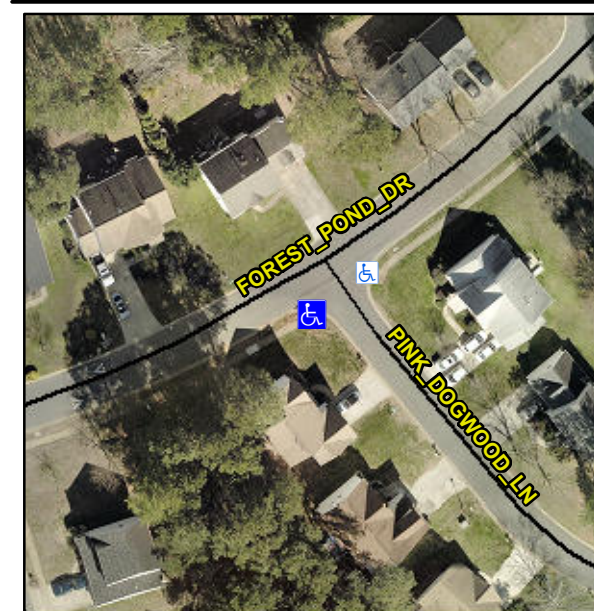
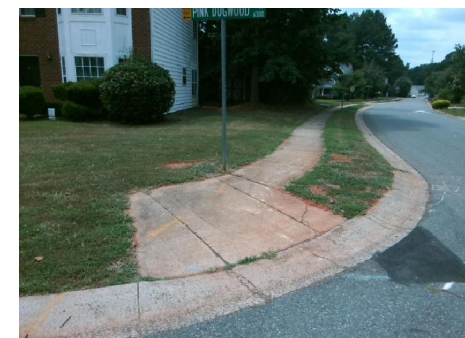
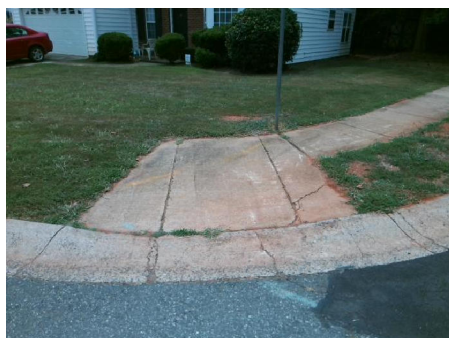
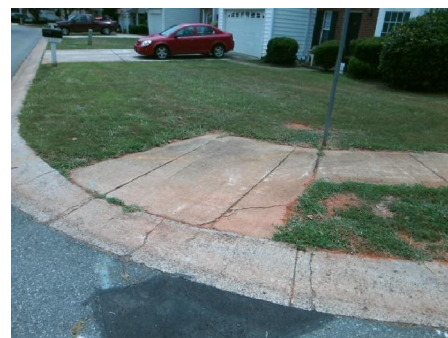
Not Found, R304.5.1, R304.5.3

Compliance	Description	Data	Compliance	Description	Data
N/A	Ramp Length (in)	98.0	Yes	BlendTrans Slope (%)	4.9
No	Ramp Width (in)	46.0	No	BlendTrans XSlope (%)	4.2
N/A	Flare Type LT	N/A	N/A	Flare Type RT	N/A
N/A	Flare Slope LT (%)	N/A	N/A	Flare Slope RT (%)	N/A
N/A	Flare Traversable LT?	N/A	N/A	Flare Traversable RT?	N/A
N/A	Landing Length (in)	N/A	N/A	DWS Provided?	N/A
N/A	Landing Width (in)	N/A	N/A	DWS Contrast?	N/A
N/A	Landing Slope (%)	N/A	N/A	DWS Length (in)	N/A
N/A	Landing X Slope (%)	N/A	N/A	DWS Full Width?	N/A
N/A	Landing Curb? (Y/N)	N/A	N/A	DWS Offset (in)	N/A
N/A	Shared Landing?	N/A			
N/A	Gutter Ponding?	N/A	N/A	Gutter Slope (%)	N/A
N/A	Gutter Lip Ht (in)	N/A	N/A	Gutter X Slope (%)	N/A
N/A	Painted X Walk1?	No	N/A	Painted X Walk2?	N/A
	X Walk 1 Direction	To NE		X Walk 2 Direction	N/A
	X Walk 1 Width (in)	N/A		X Walk 2 Width (in)	N/A
	X Walk 1 Slope (%)	3.6		X Walk 2 Slope (%)	N/A
	X Walk 1 X Slope (%)	2.9		X Walk 2 X Slope (%)	N/A

N/A	Ramp inside XWalk1?	N/A	N/A	Ramp inside XWalk2?	N/A
	Road Slope (%)	2.9		Clear Space?	N/A
	Road X Slope (%)	3.6	N/A	Clear Space to XWalk (in)	N/A
N/A	Any Obstructions?	N/A	N/A	Storm Grate/Utility Hazard?	N/A
	Obstruction Type			Storm Grate/Utility Type	
		N/A			N/A
			Yes	Surface Condition? (G/P)	Good
			No	Curb Slope (%)	9.6

Remove & Replace Curb Ramp With Two New Directional Ramps or Equivalent.
