# Access Compliance Report

## Public Rights-of-Way

### (Curb Ramps)

Intersection ID: 14193	Main Street: E_5TH_ST	Cross Street: N_CASWELL_RD	Location: E
ADA ID: 284991F6AE64	Ramp Type: PerpDiag	Initial Pass/Fail: Fail	Overall Compliance: No
Severity Score: 25			
Codes/Mitigation Info/Possible Solution		Field Measurements/Component Compliance

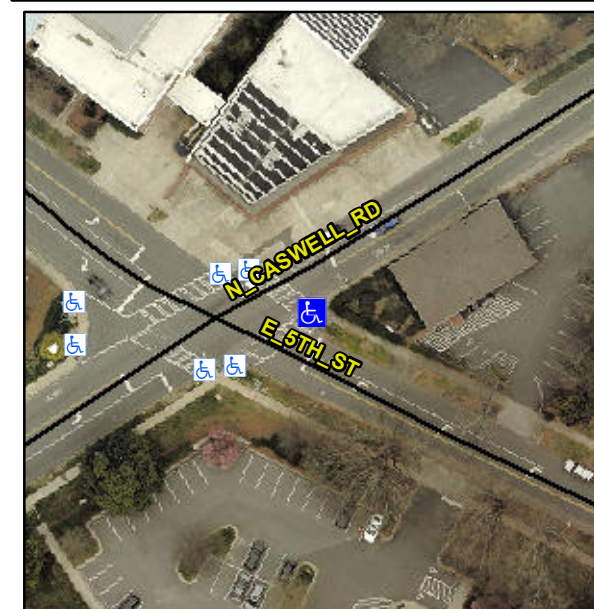
Compliance	Description	Data	Compliance	Description	Data
N/A	Ramp Length (in)	48.0	No	Ramp Slope (%)	14.3
Yes	Ramp Width (in)	48.0	Yes	Ramp XSlope (%)	0.3
N/A	Flare Type LT	N/A	N/A	Flare Type RT	N/A
N/A	Flare Slope LT (%)	N/A	N/A	Flare Slope RT (%)	N/A
N/A	Flare Traversable LT?	N/A	N/A	Flare Traversable RT?	N/A
N/A	Landing Length (in)	N/A	N/A	DWS Provided?	N/A
N/A	Landing Width (in)	N/A	N/A	DWS Contrast?	N/A
N/A	Landing Slope (%)	N/A	N/A	DWS Length (in)	N/A
N/A	Landing X Slope (%)	N/A	N/A	DWS Full Width?	N/A
N/A	Landing Curb? (Y/N)	N/A	N/A	DWS Offset (in)	N/A
N/A	Shared Landing?	N/A			
N/A	Gutter Ponding?	N/A	N/A	Gutter Slope (%)	N/A
N/A	Gutter Lip Ht (in)	N/A	N/A	Gutter X Slope (%)	N/A
N/A	Painted X Walk1?	Yes	N/A	Painted X Walk2?	Yes
	X Walk 1 Direction	To NW		X Walk 2 Direction	To SW
N/A	X Walk 1 Width (in)	118.0	N/A	X Walk 2 Width (in)	118.0
	X Walk 1 Slope (%)	3.3		X Walk 2 Slope (%)	5.0
	X Walk 1 X Slope (%)	2.6		X Walk 2 X Slope (%)	2.7

N/A	Ramp inside XWalk1?	Yes	N/A	Ramp inside XWalk2?	Yes
	Road Slope (%)	1.2	N/A	Clear Space?	N/A
	Road X Slope (%)	3.7	N/A	Clear Space to XWalk (in)	N/A
N/A	Any Obstructions?	N/A	N/A	Storm Grate/Utility Hazard?	N/A
	Obstruction Type			Storm Grate/Utility Type	
		N/A			N/A
		Yes		Surface Condition? (G/P)	Good

Possible Solutions:

**Remove & Replace Curb Ramp With Two New Directional Ramps or Equivalent.**

**Not Found, R304.2.2**
