# Access Compliance Report

## Public Rights-of-Way

### (Curb Ramps)

Intersection ID: N/A	Main Street: MONROE_RD	Cross Street: N/A	Location: SW
ADA ID: 2849F873BD67	Ramp Type: Directional1	Initial Pass/Fail: Fail	Overall Compliance: No
		Severity Score: 13.75

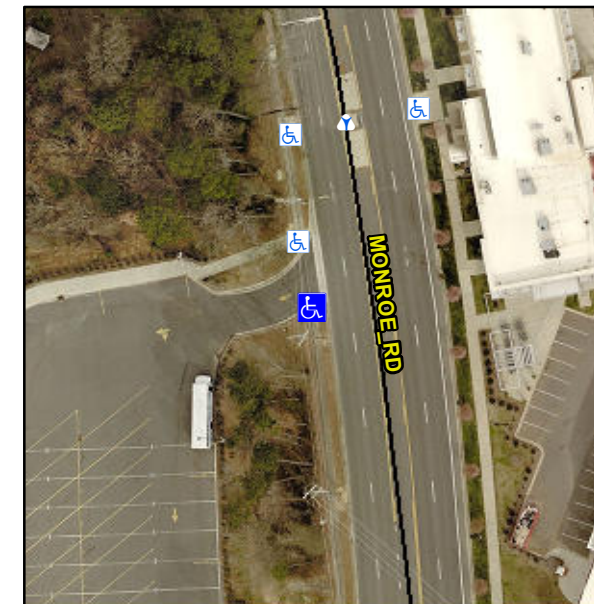
**DWS DETACHED/NAILS EXPOSED**

**R304.2.2**

Compliance	Description	Data	Compliance	Description	Data
N/A	Ramp Length (in)	89.0	N/A	Grade Break?	N/A
Yes	Ramp Width (in)	62.0	N/A	Grade Break Slope (%)	0.0
No	Ramp Slope (%)	11.1	N/A	Grade Break XSlope (%)	0.0
Yes	Ramp XSlope (%)	2.2			
N/A	Flare Type LT	N/A	N/A	Flare Type RT	N/A
N/A	Flare Slope LT (%)	N/A	N/A	Flare Slope RT (%)	0.0
N/A	Flare Traversable LT?	N/A	N/A	Flare Traversable RT?	N/A
N/A	Landing Length (in)	0.0	N/A	DWS Provided?	N/A
N/A	Landing Width (in)	0.0	N/A	DWS Contrast?	N/A
N/A	Landing Slope (%)	0.0	N/A	DWS Length (in)	N/A
N/A	Landing X Slope (%)	0.0	N/A	DWS Full Width?	N/A
N/A	Landing Curb? (Y/N)	N/A	N/A	DWS Offset LT (in)	N/A
N/A	Shared Landing?	N/A	N/A	DWS Offset RT (in)	N/A
N/A	Gutter Ponding?	0.0	N/A	Gutter Slope (%)	N/A
N/A	Gutter Lip Ht (in)	0.0	N/A	Gutter X Slope (%)	N/A
N/A	Painted X Walk1?	No		Road Slope (%)	2.8
	X Walk 1 Direction	To NW		Road X Slope (%)	2.6
	X Walk 1 Width (in)	N/A		Clear Space?	N/A

X Walk 1 Slope (%)	2.8	N/A	Clear Space to XWalk (in)	N/A
	X Walk 1 X Slope (%)	2.6	N/A	Storm Grate/Utility Hazard?	N/A
N/A	Ramp inside XWalk1?	N/A		Storm Grate/Utility Type	
N/A	Any Obstructions?	N/A			N/A
	Obstruction Type		Yes	Surface Condition? (G/P)	Good
			N/A	Curb Slope (%)	10.8

**Remove & Replace Entire Ramp.**
