Access Compliance Report Public Rights-of-Way (Curb Ramps)

Intersection ID: 7648 Main Street: STARITA_RD Cross Street: WOODPARK_BV Location: SE **Overall Compliance: No** ADA ID: 2856AF51E122 Ramp Type: Perp Initial Pass/Fail: Fail **Severity Score:** 1.25

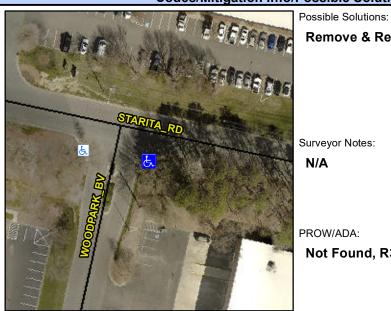
Comp	oliance Description	Data	Comp	liance Description	Data
N/A	Ramp Length (in)	62.0	Yes	Ramp Slope (%)	8.0
Yes	Ramp Width (in)	60.0	No	Ramp XSlope (%)	3.0
N/A	Flare Type LT	N/A	N/A	Flare Type RT	N/A
N/A	Flare Slope LT (%)	N/A	N/A	Flare Slope RT (%)	N/A
N/A	Flare Traversable LT?	N/A	N/A	Flare Traversable RT?	N/A
N/A	Landing Length (in)	N/A	N/A	DWS Provided?	N/A
N/A	Landing Width (in)	N/A	N/A	DWS Contrast?	N/A
N/A	Landing Slope (%)	N/A	N/A	DWS Length (in)	N/A
N/A	Landing X Slope (%)	N/A	N/A	DWS Full Width?	N/A
N/A	Landing Curb? (Y/N)	N/A	N/A	DWS Offset (in)	N/A
N/A	Shared Landing?	N/A			
N/A	Gutter Ponding?	N/A	N/A	Gutter Slope (%)	N/A
N/A	Gutter Lip Ht (in)	N/A	N/A	Gutter X Slope (%)	N/A
N/A	Painted X Walk1?	No	N/A	Painted X Walk2?	N/A
	X Walk 1 Direction	To NW		X Walk 2 Direction	N/A
N/A	X Walk 1 Width (in)	N/A	N/A	X Walk 2 Width (in)	N/A
	X Walk 1 Slope (%)	1.0		X Walk 2 Slope (%)	N/A
	X Walk 1 X Slope (%)	7.4		X Walk 2 X Slope (%)	N/A

N/A	Ramp inside XWalk1?	N/A	N/A	Ramp inside XWalk2?	N/A
	Road Slope (%)	N/A	N/A	Clear Space?	N/A
	Road X Slope (%)	N/A	N/A	Clear Space to XWalk (in)	N/A
N/A	Any Obstructions?	N/A	N/A	Storm Grate/Utility Hazard?	N/A
	Obstruction Type		l	Storm Grate/Utility Type	
		N/A			N/A
			Yes	Surface Condition? (G/P)	Good

OSSIDIE SOIULIONS.	<u>C01</u>
Remove & Replace Entire Ramp.	N/A
	Yes
	N/A
	N/A
	N/A
	N/A
surveyor Notes:	N/A
N/A	N/A
	N/A
	N/A
	N/A
ROW/ADA:	N/A
Not Found, R304.5.3	N/A
,	N/A
	N/A
	N/A

,		
Total Cost:			\$ 1850.00
