Access Compliance Report Public Rights-of-Way (Curb Ramps)

Intersection ID: 49932 Main Street: WOBURN_RD Cross Street: PAXTON_RUN_RD Location: NW

ADA ID: 285B43EA72FA Ramp Type: Perp Initial Pass/Fail: Pass Overall Compliance: No Severity Score: 0

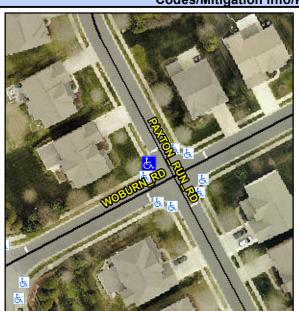
, , , , , , , , , , , , , , , , , , ,			, , , , , , , , , , , , , , , , , , ,	
Α	Flare Slope LT (%)	4.9	Yes	Flare Slope RT (%)	4.7
Α	Flare Traversable LT?	Yes	N/A	Flare Traversable RT?	Yes
s	Landing Length (in)	48.0	Yes	DWS Provided?	Yes
s	Landing Width (in)	48.0	Yes	DWS Contrast?	Yes
)	Landing Slope (%)	3.5	Yes	DWS Length (in)	24.5
s	Landing X Slope (%)	1.4	Yes	DWS Full Width?	Yes
Α	Landing Curb? (Y/N)	No	Yes	DWS Offset (in)	2.0
Α	Shared Landing?	No			
)	Gutter Ponding?	Yes	Yes	Gutter Slope (%)	1.5
s	Gutter Lip Ht (in)	0.0	Yes	Gutter X Slope (%)	0.1
Α	Painted X Walk1?	No	N/A	Painted X Walk2?	N/A
	X Walk 1 Direction	To NE		X Walk 2 Direction	N/A
Α	X Walk 1 Width (in)	N/A	N/A	X Walk 2 Width (in)	N/A
	X Walk 1 Slope (%)	0.2		X Walk 2 Slope (%)	N/A
	X Walk 1 X Slope (%)	0.4		X Walk 2 X Slope (%)	N/A
Α	Ramp inside XWalk1?	N/A	N/A	Ramp inside XWalk2?	N/A
	Road Slope (%)	N/A	N/A	Clear Space?	Yes
	Road X Slope (%)	N/A	N/A	Clear Space to XWalk (in)	N/A

es	Any Obstructions?	No	Yes	Storm Grate/Utility Hazard?	No
	Obstruction Type			Storm Grate/Utility Type	
		N/A			N/A
			Yes	Surface Condition? (G/P)	Good

Possible Solutions:

Remove & Replace Entire Ramp.
