Access Compliance Report

Public Rights-of-Way

(Curb Ramps)

Intersection ID: 2675	Main Street: HEATHCREST_CT	Cross Street: MCCHESENEY_DR	Location: E
ADA ID: 2868D15368F7	Ramp Type: PerpDiag	Initial Pass/Fail: Fail	Overall Compliance: No
		Severity Score: 12.5

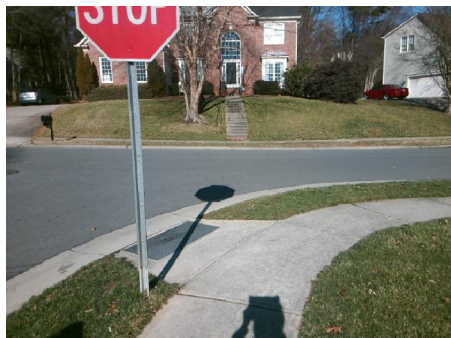
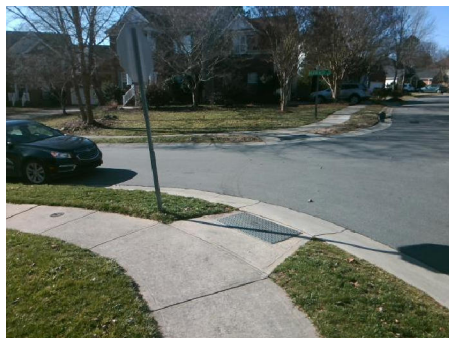
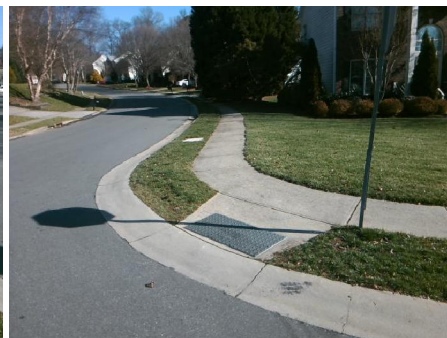
Compliance	Description	Data	Compliance	Description	Data
N/A	Ramp Length (in)	50.0	Yes	Ramp Slope (%)	6.5
Yes	Ramp Width (in)	61.0	No	Ramp XSlope (%)	5.1
N/A	Flare Type LT	N/A	N/A	Flare Type RT	N/A
N/A	Flare Slope LT (%)	N/A	N/A	Flare Slope RT (%)	N/A
N/A	Flare Traversable LT?	N/A	N/A	Flare Traversable RT?	N/A
N/A	Landing Length (in)	N/A	N/A	DWS Provided?	N/A
N/A	Landing Width (in)	N/A	N/A	DWS Contrast?	N/A
N/A	Landing Slope (%)	N/A	N/A	DWS Length (in)	N/A
N/A	Landing X Slope (%)	N/A	N/A	DWS Full Width?	N/A
N/A	Landing Curb? (Y/N)	N/A	N/A	DWS Offset (in)	N/A
N/A	Shared Landing?	N/A			
N/A	Gutter Ponding?	N/A	N/A	Gutter Slope (%)	N/A
N/A	Gutter Lip Ht (in)	N/A	N/A	Gutter X Slope (%)	N/A
N/A	Painted X Walk1?	No	N/A	Painted X Walk2?	No
	X Walk 1 Direction	To SW		X Walk 2 Direction	To NW
N/A	X Walk 1 Width (in)	N/A	N/A	X Walk 2 Width (in)	N/A
	X Walk 1 Slope (%)	3.0		X Walk 2 Slope (%)	3.0
	X Walk 1 X Slope (%)	4.8		X Walk 2 X Slope (%)	1.6

N/A	Ramp inside XWalk1?	N/A	N/A	Ramp inside XWalk2?	N/A
	Road Slope (%)	2.9	N/A	Clear Space?	N/A
	Road X Slope (%)	4.9	N/A	Clear Space to XWalk (in)	N/A
N/A	Any Obstructions?	N/A	N/A	Storm Grate/Utility Hazard?	N/A
	Obstruction Type			Storm Grate/Utility Type	
		N/A			N/A
			Yes	Surface Condition? (G/P)	Good

Remove & Replace Curb Ramp With Two New Directional Ramps or Equivalent.
