# Access Compliance Report

## Public Rights-of-Way

### (Curb Ramps)

| Intersection ID: 14154 | Main Street: DILWORTH_RD | Cross Street: MT_VERNON_AV | Location: NW |

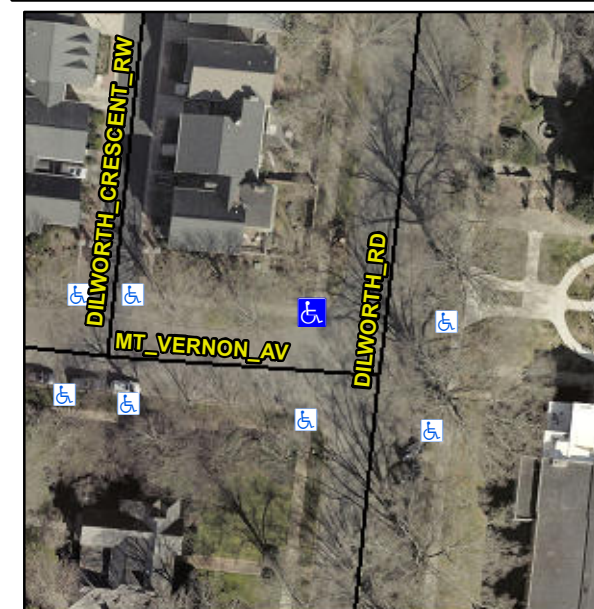
**ASP LIP 1.0**

**Not Found, R304.5.3**

| Compliance | Description | Data | Compliance | Description | Data |
|---|---|---|---|---|---|
| Yes | Ramp Width (in) | 150.0 | No | BlendTrans XSlope (%) | 6.1 |
| | | | No | Curb Slope (%) | 5.4 |

**Remove & Replace Curb Ramp With Two New Directional Ramps or Equivalent.**

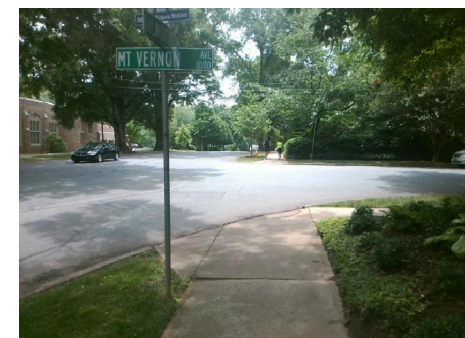
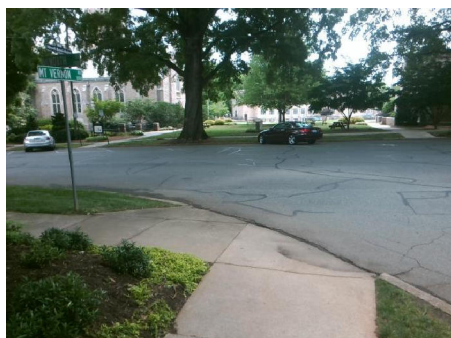
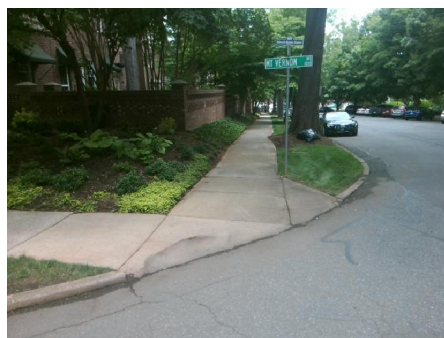
Street 1 Name MT VERNON AV  
 Stop Condition-Street 1 StopSign  
 Street 2 Name DILWORTH RD  
 Stop Condition-Street 2 None
